# Indian River Club Condominium

## Structural Condition Survey Report

Prepared By  
**Michael M. Hallenstein, MSCE, P.E.**  
Florida Registered Professional Engineer #98630

**June 8, 2026**

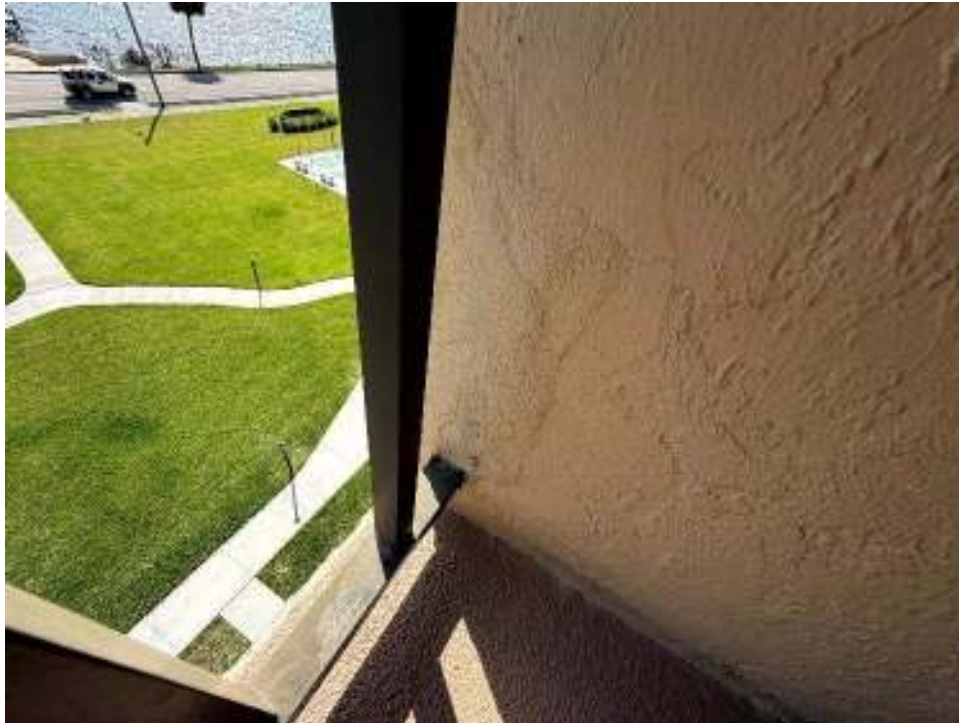
View of column spall due to reinforcing steel corrosion

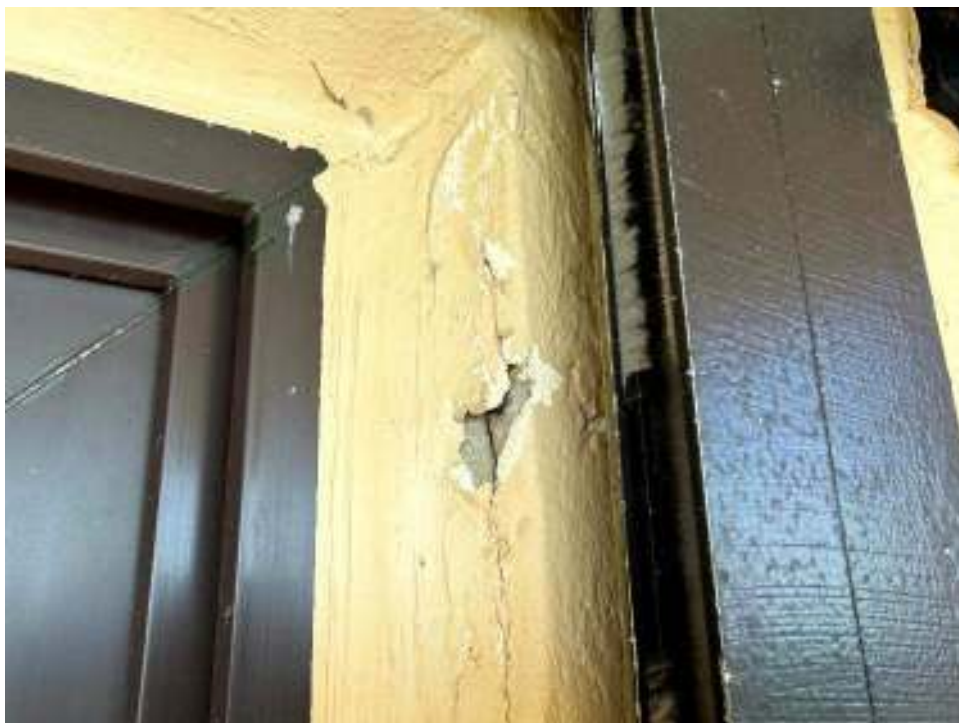
View of column spall due to reinforcing steel corrosion

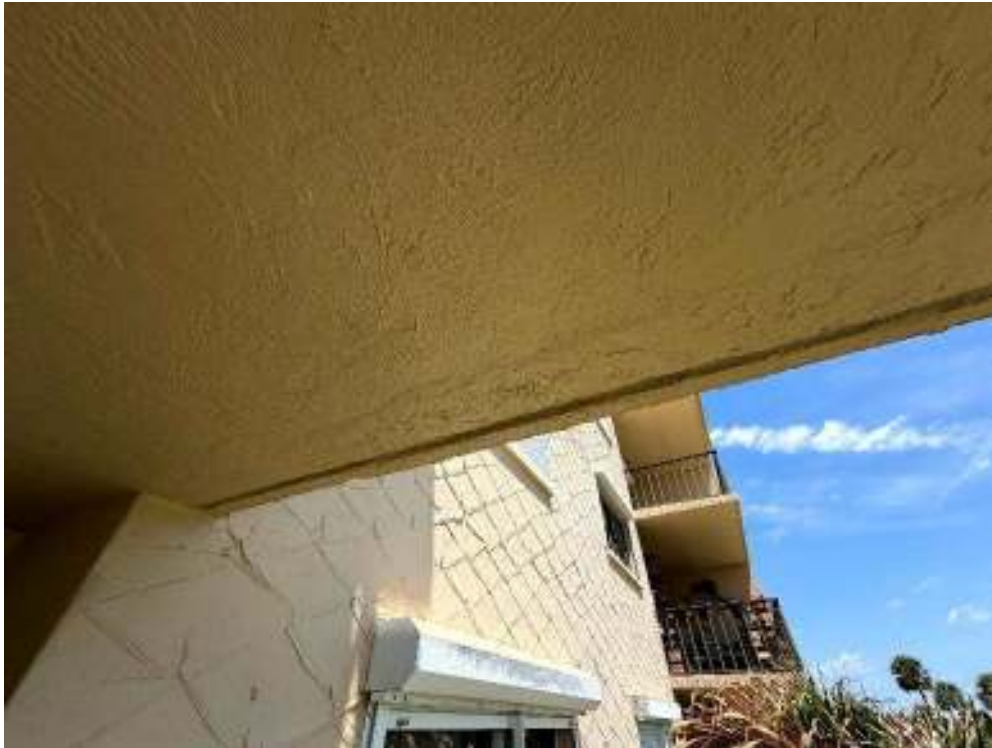
View of delaminated stucco

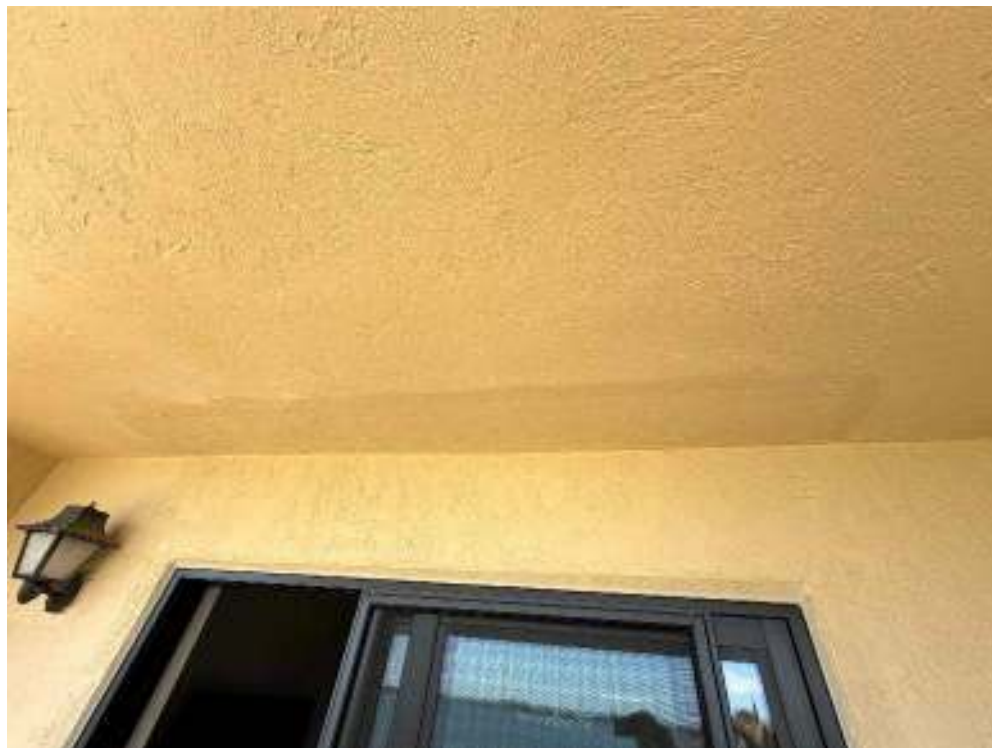
View of previous ceiling repair

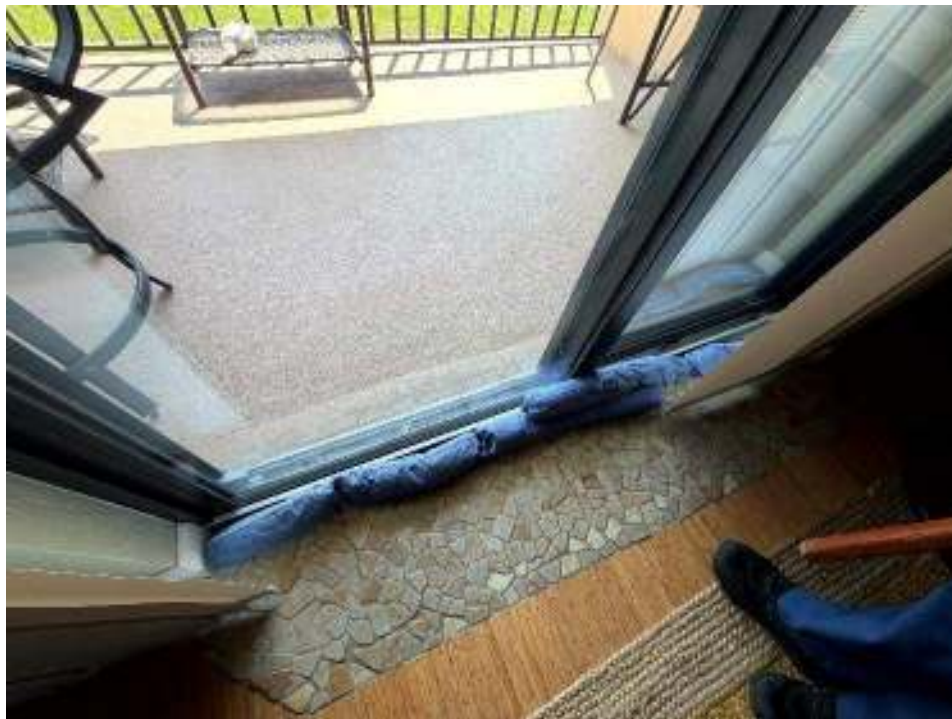
View of sliding glass door with possible water intrusion

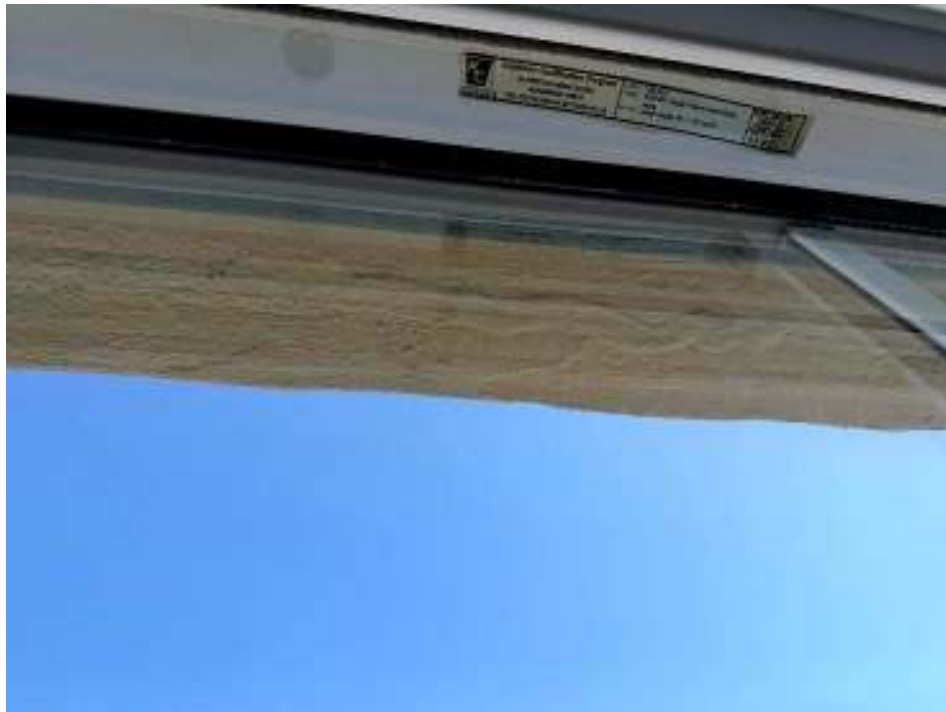
**View of crack patch at window**

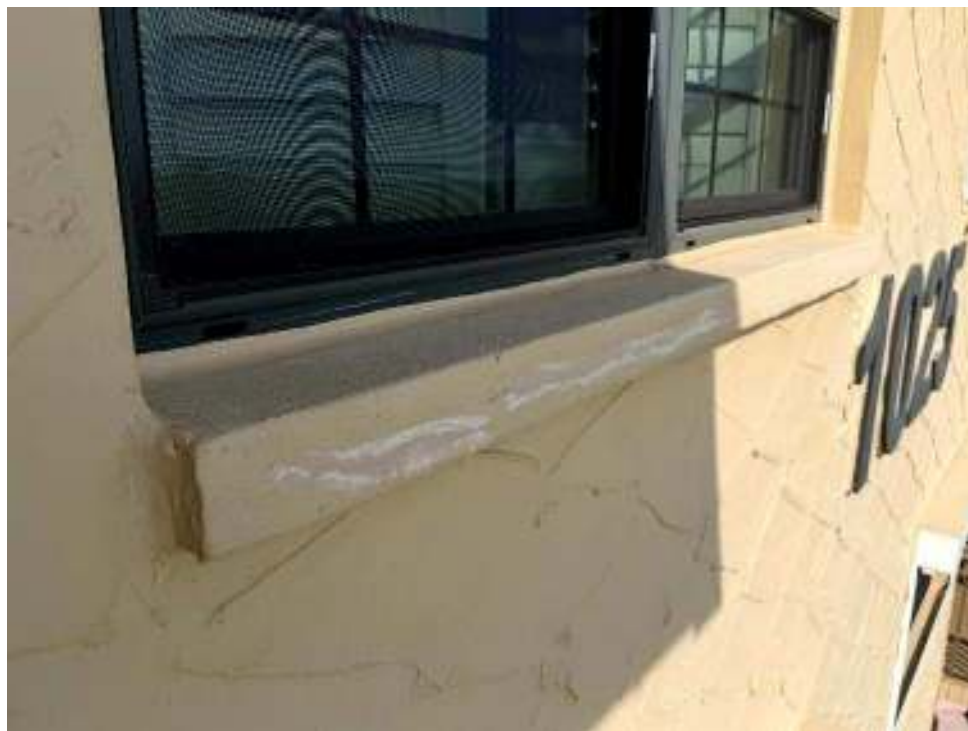
**View of patched windowsill spall**

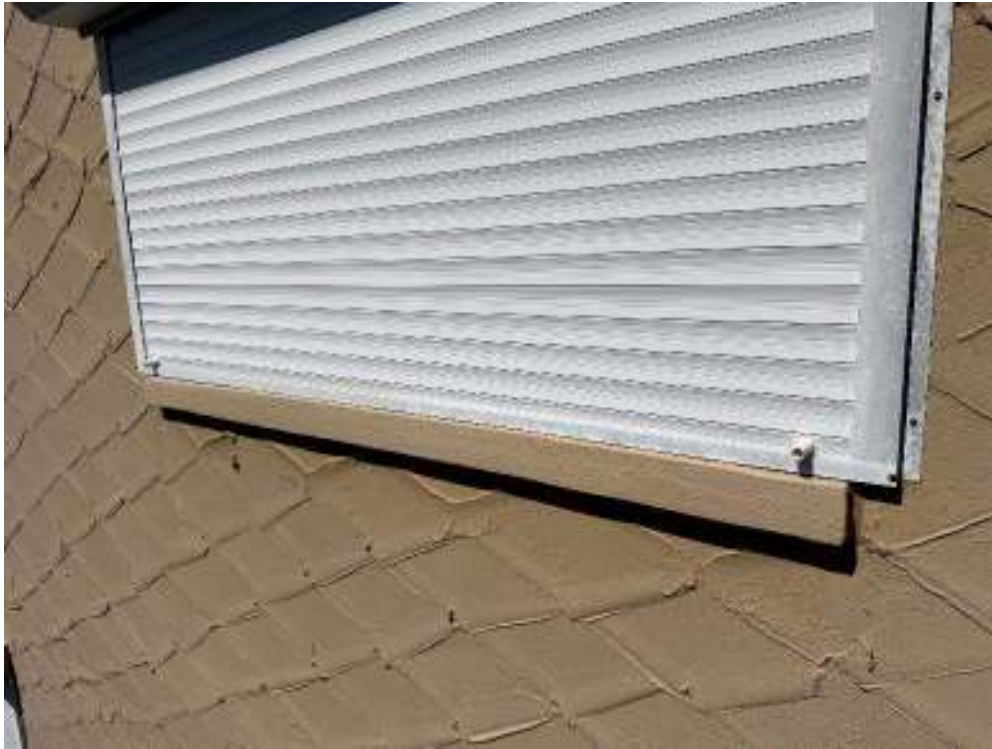
View of windowsill spall

Note bottom of shutter frame may prevent water from draining away from the window

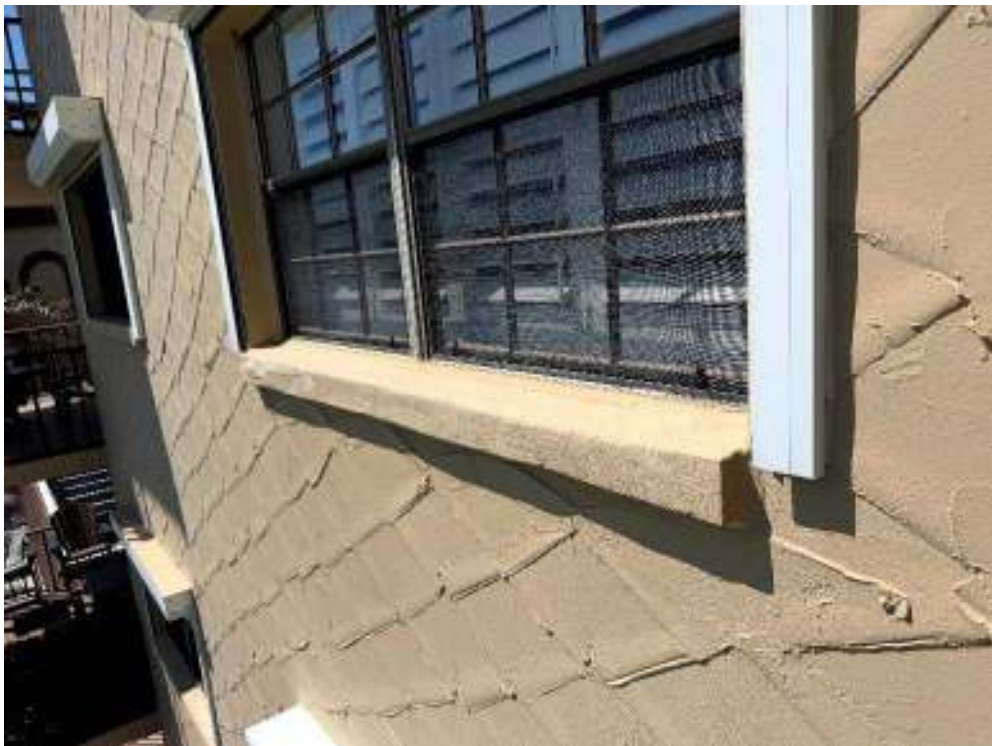
View of windowsill spall due to reinforcing steel corrosion

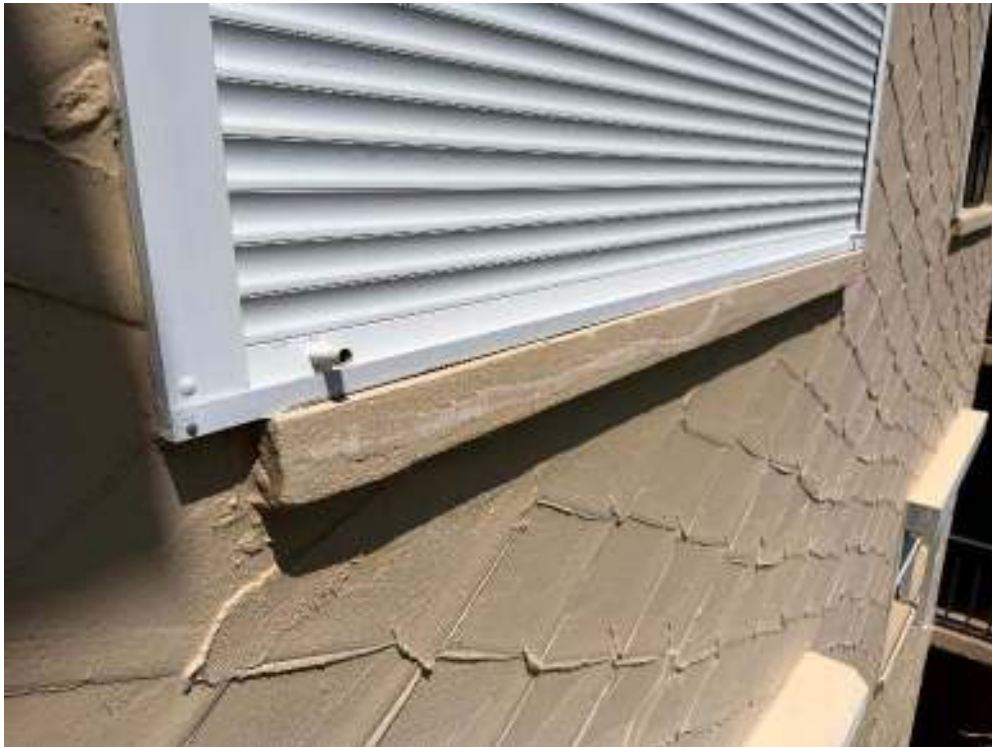
View of “patched” windowsill spall

Note bottom of shutter frame may prevent water from draining away from the window

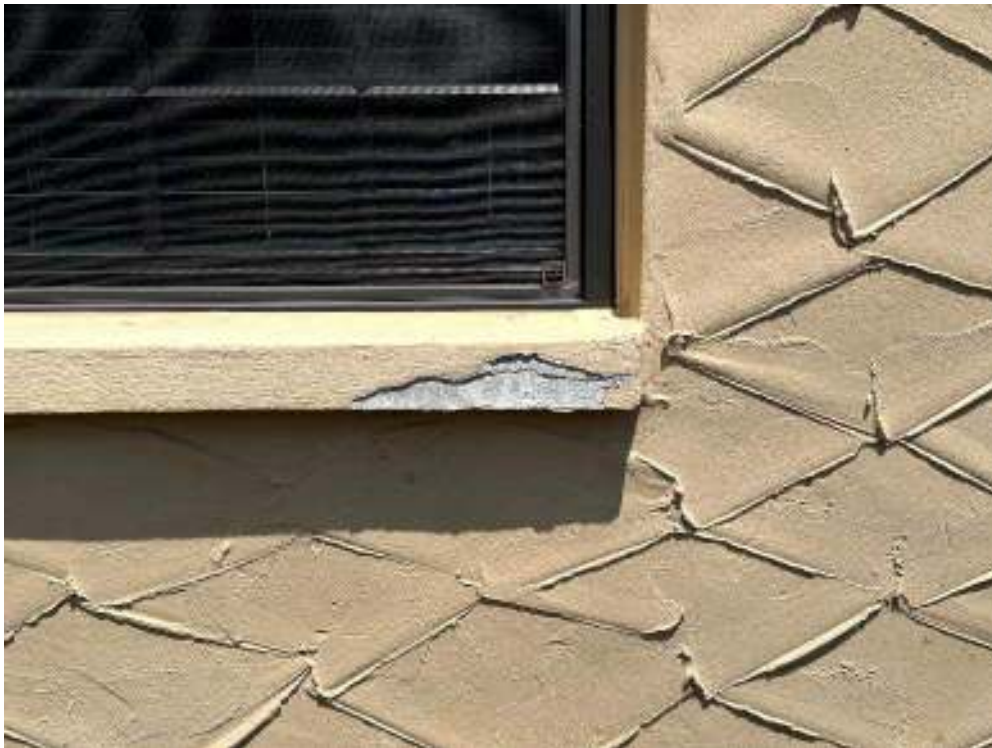
View of windowsill spall

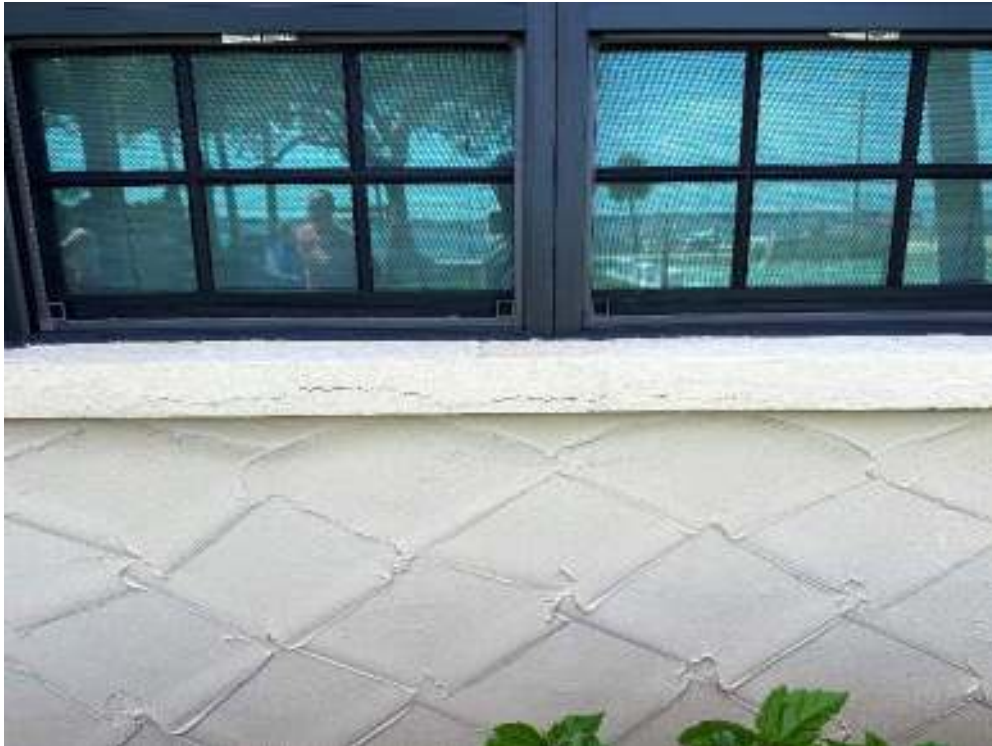
View of windowsill spall due to reinforcing steel corrosion

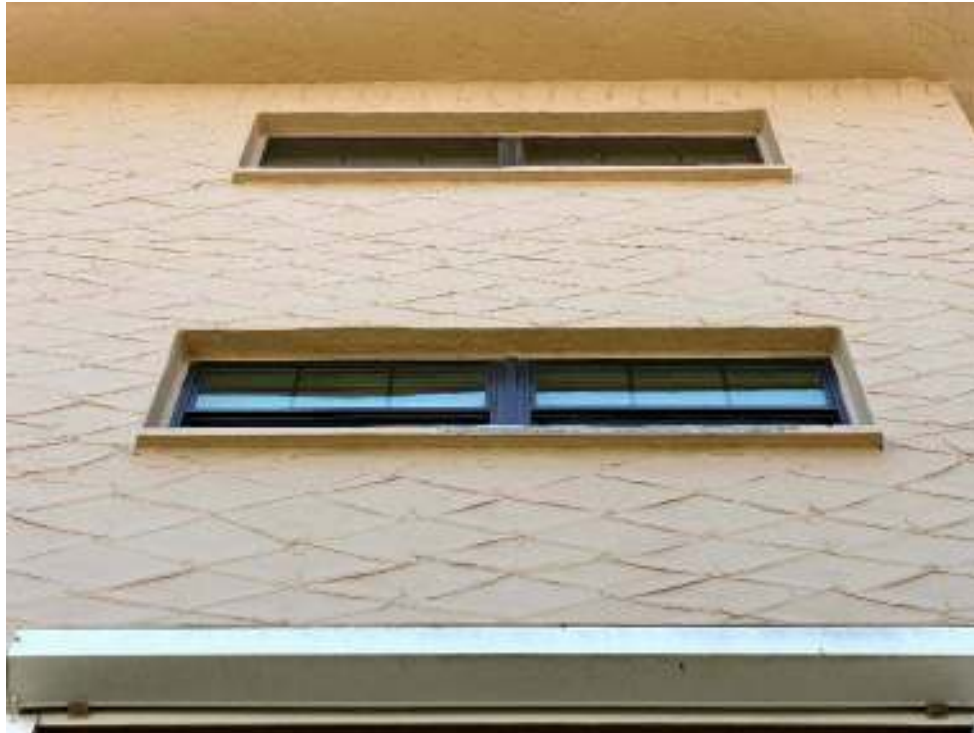
View of “patched” windowsill spall

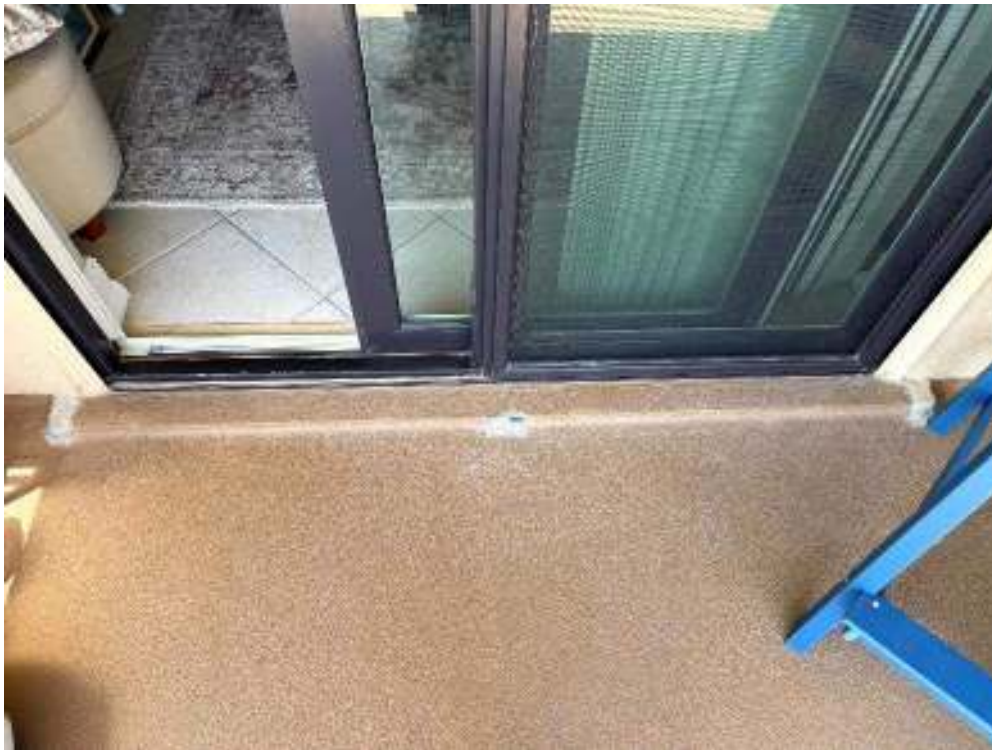
View of typical balcony coatings  
Note missing coatings where shutter frame was installed

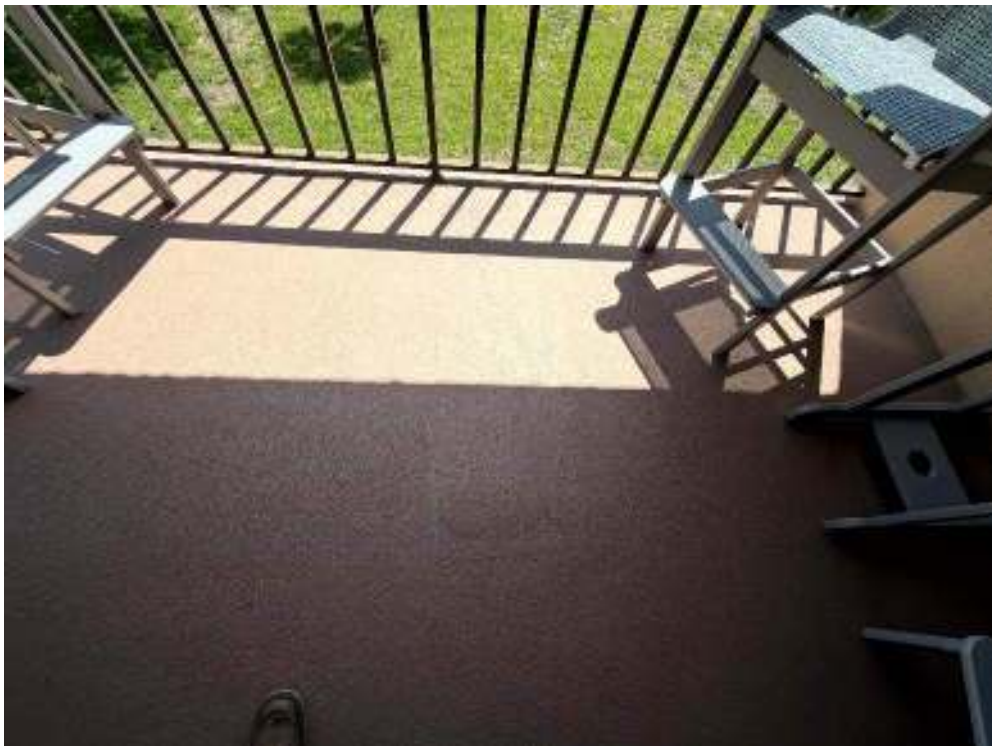
View of typical coatings  
Note previous repair

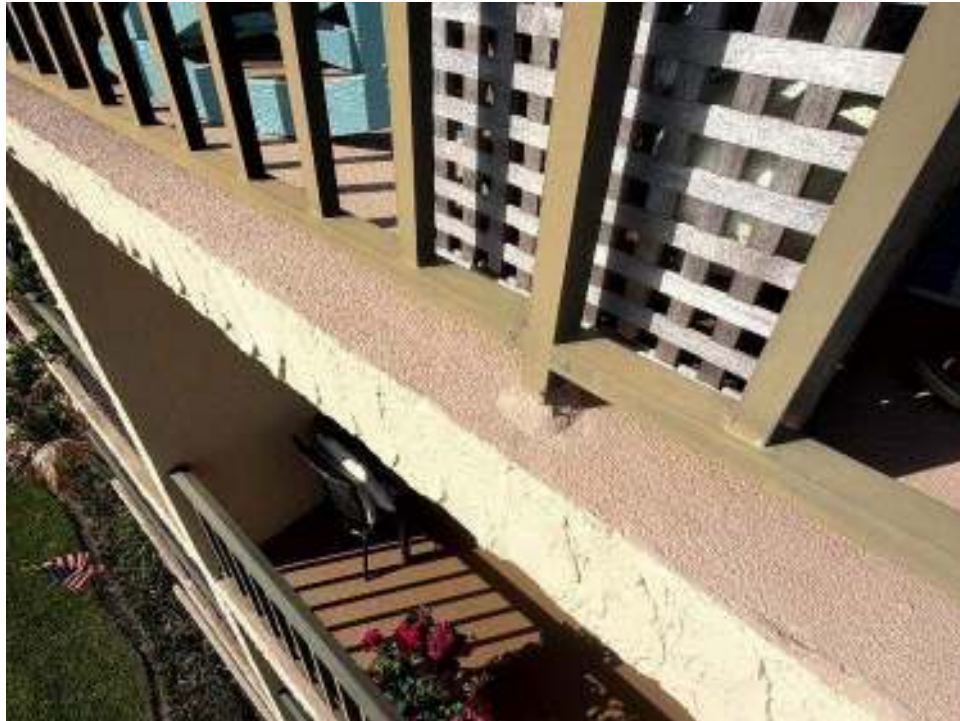
View of typical cored railing with deteriorating coatings

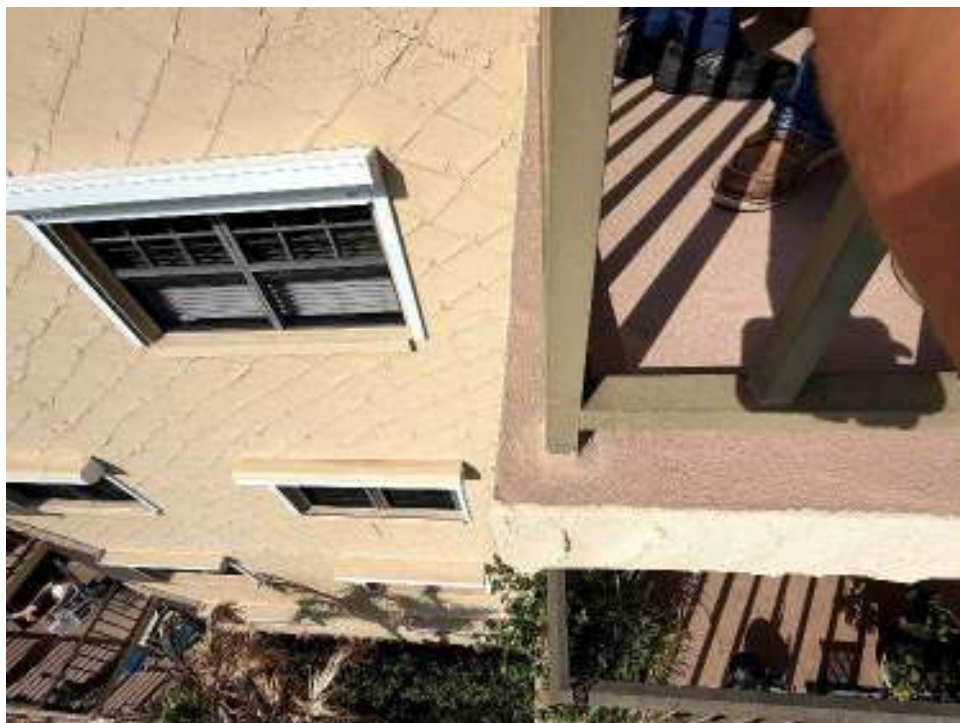
View of typical cored railing with deteriorating coatings

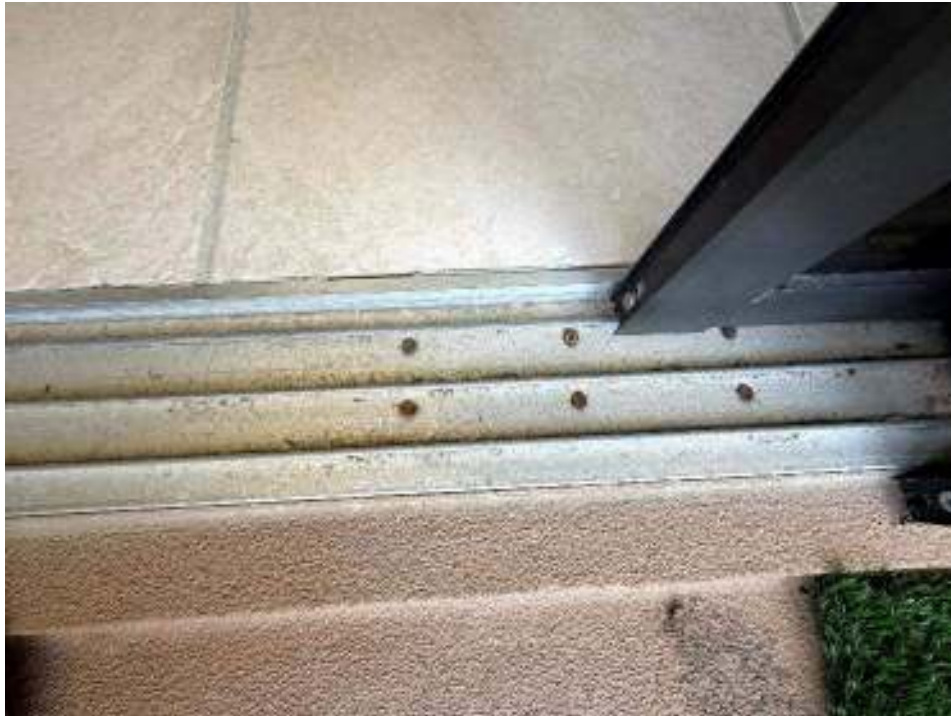
**View of older sliding glass door**  
**Note corroded fasteners and deteriorating door coatings**

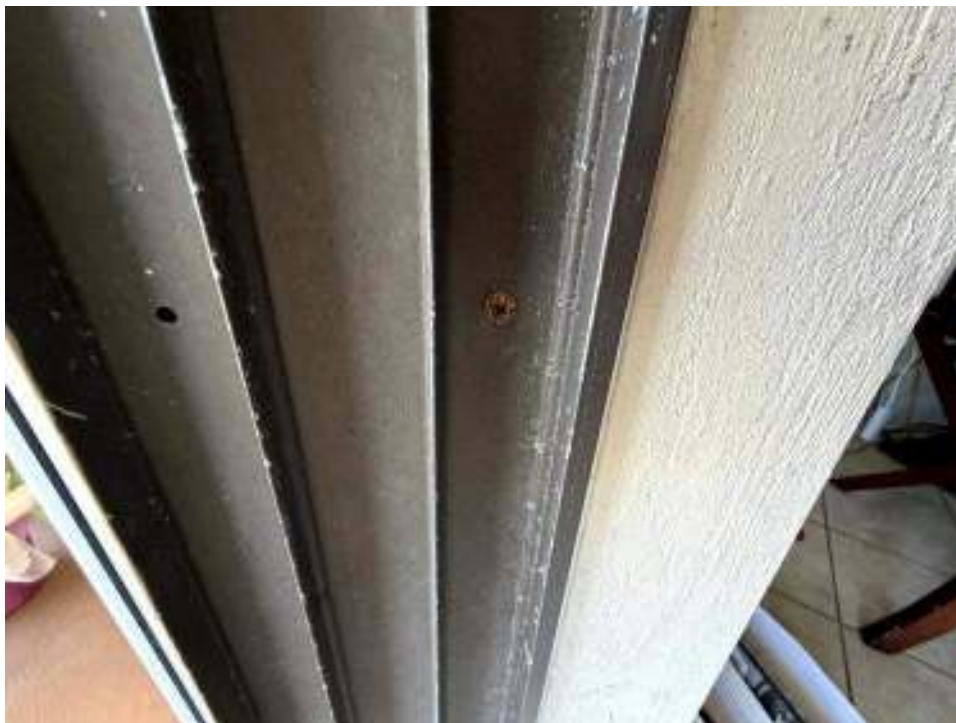
**View of missing and corroded sliding glass doors fasteners**

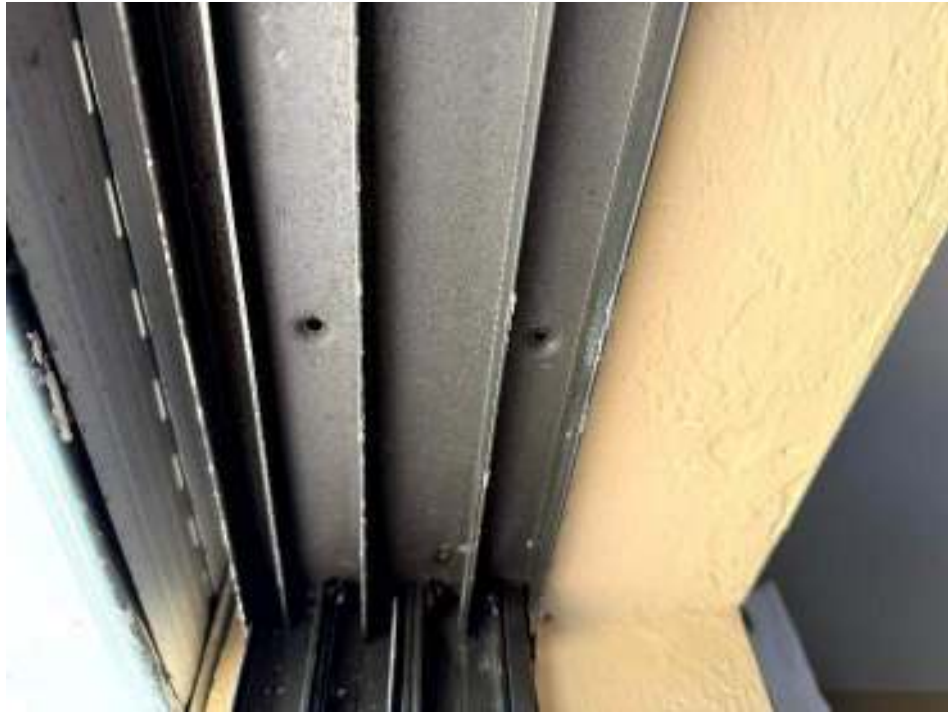
View of missing sliding glass door fasteners

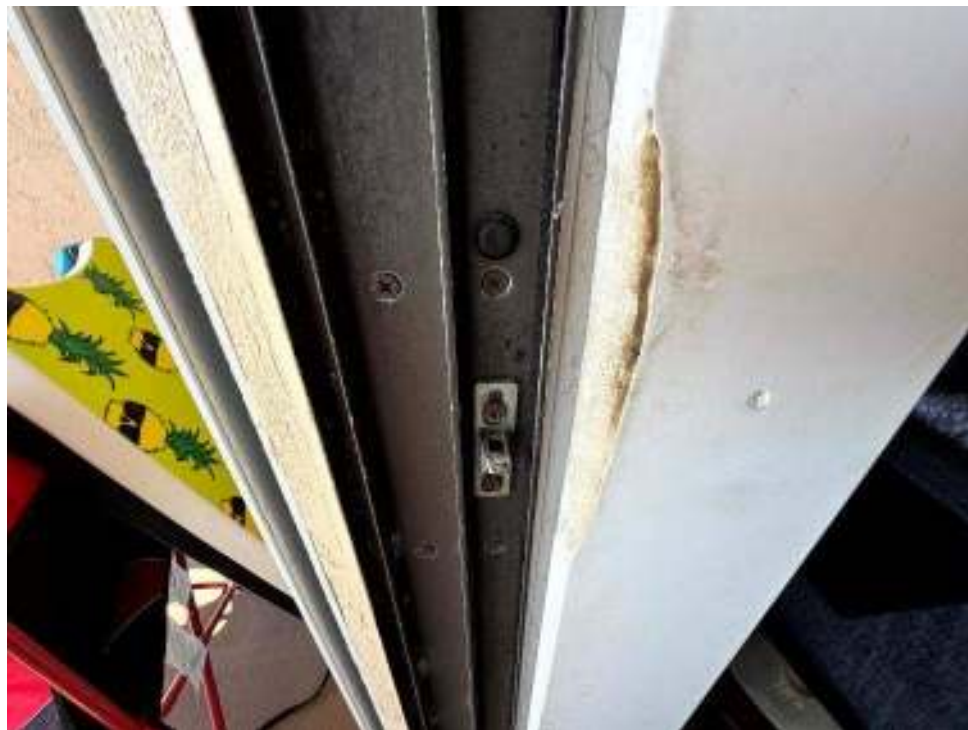
View of corroded sliding glass door fasteners

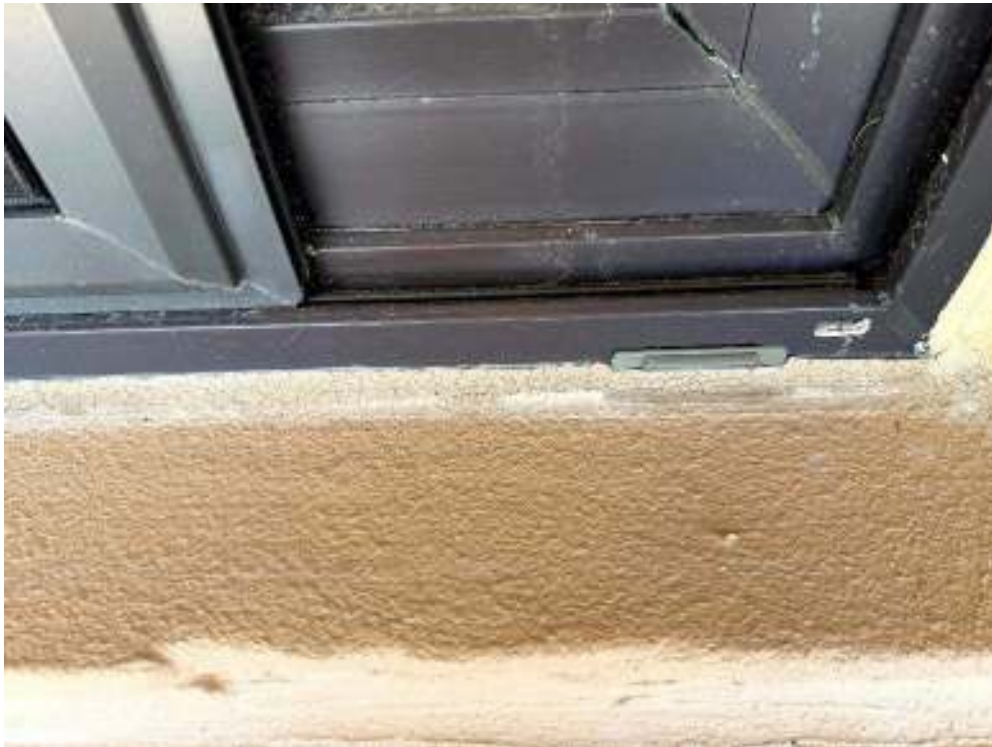
View of failing perimeter sealant at sliding glass door

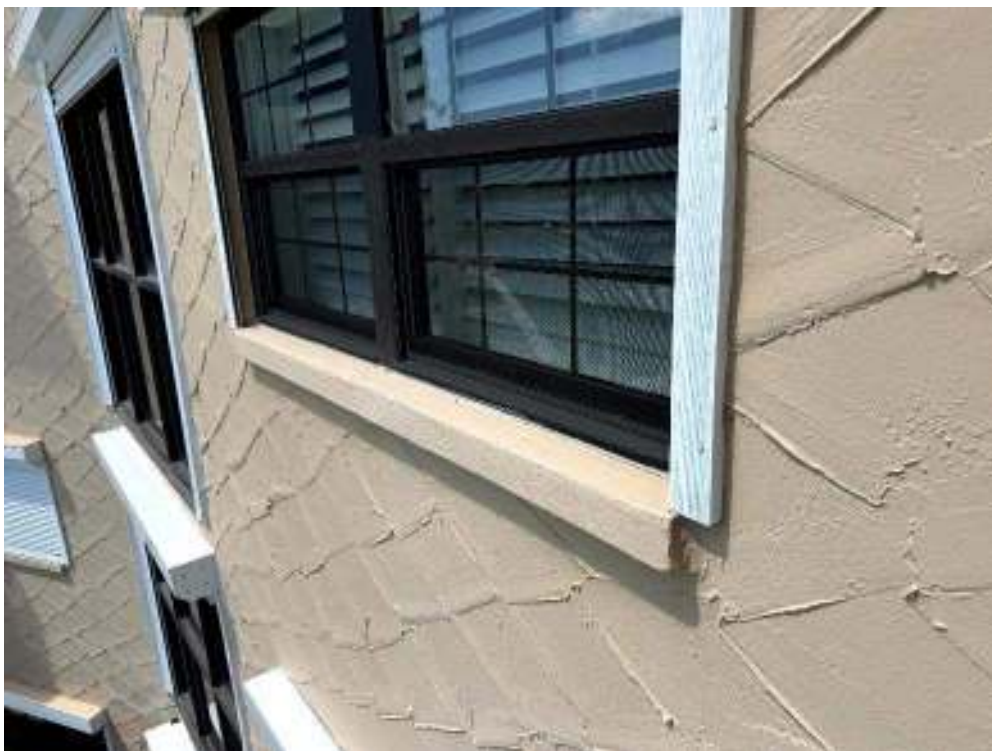
View of failing perimeter sealant at window

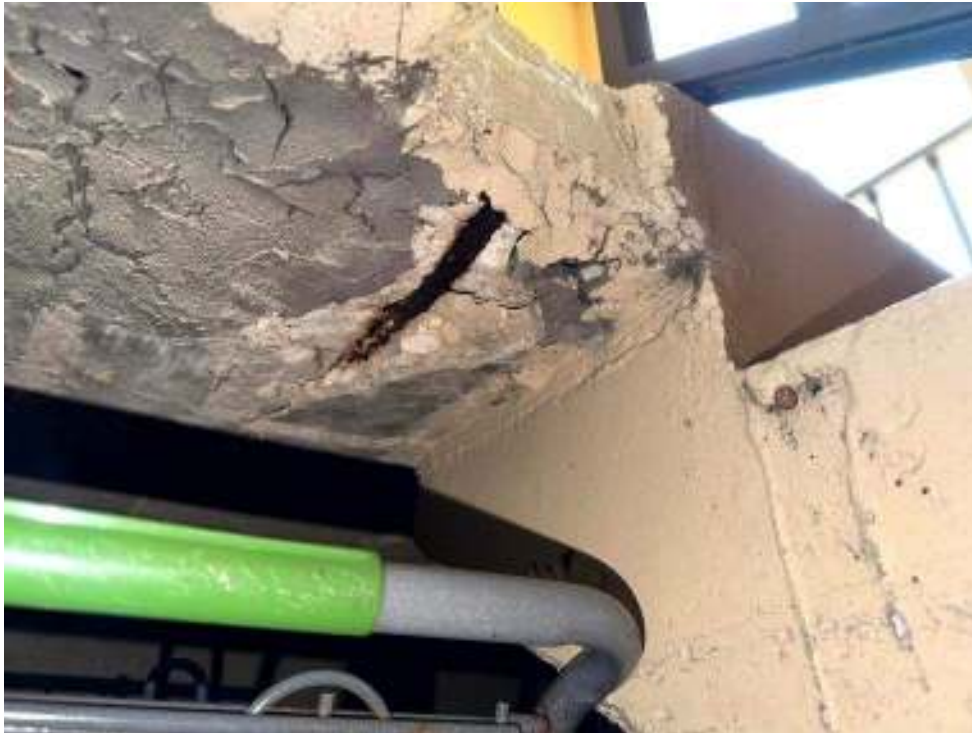
View of spall underneath stairs

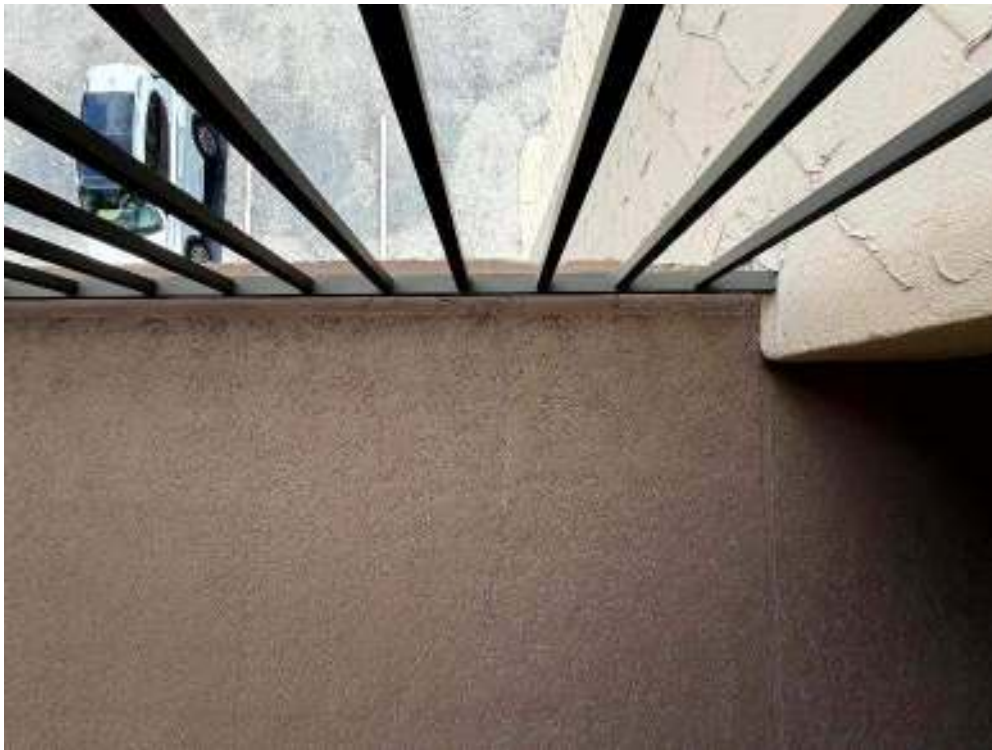
View of crack along walkway slab

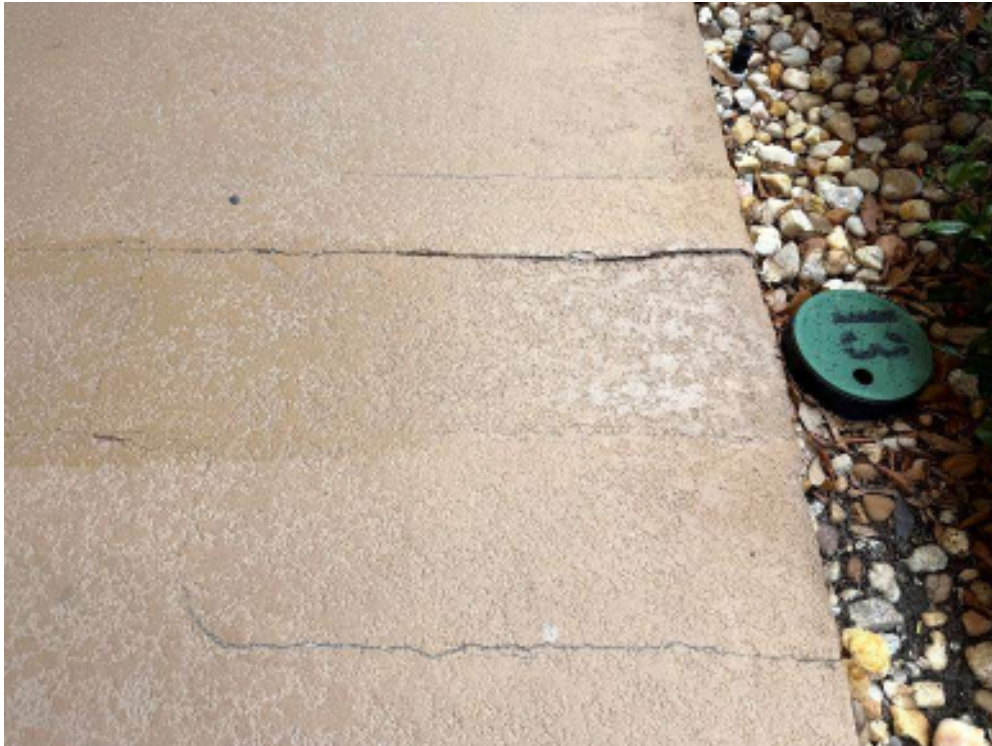
View of crack along ground floor walkway slab

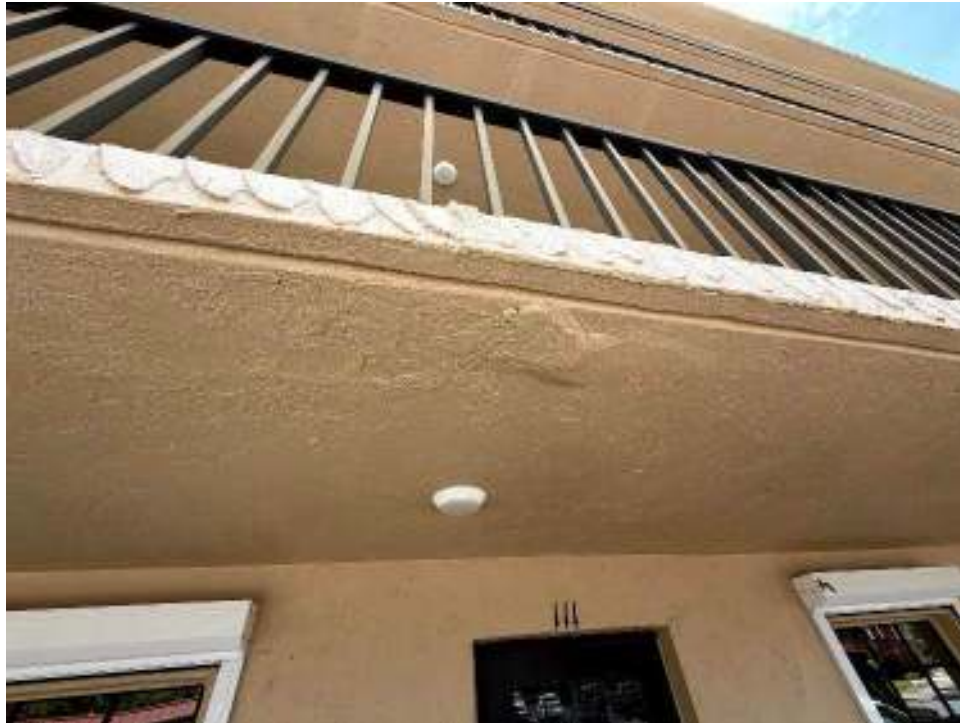
View of edge spall along ground floor ceiling walkway

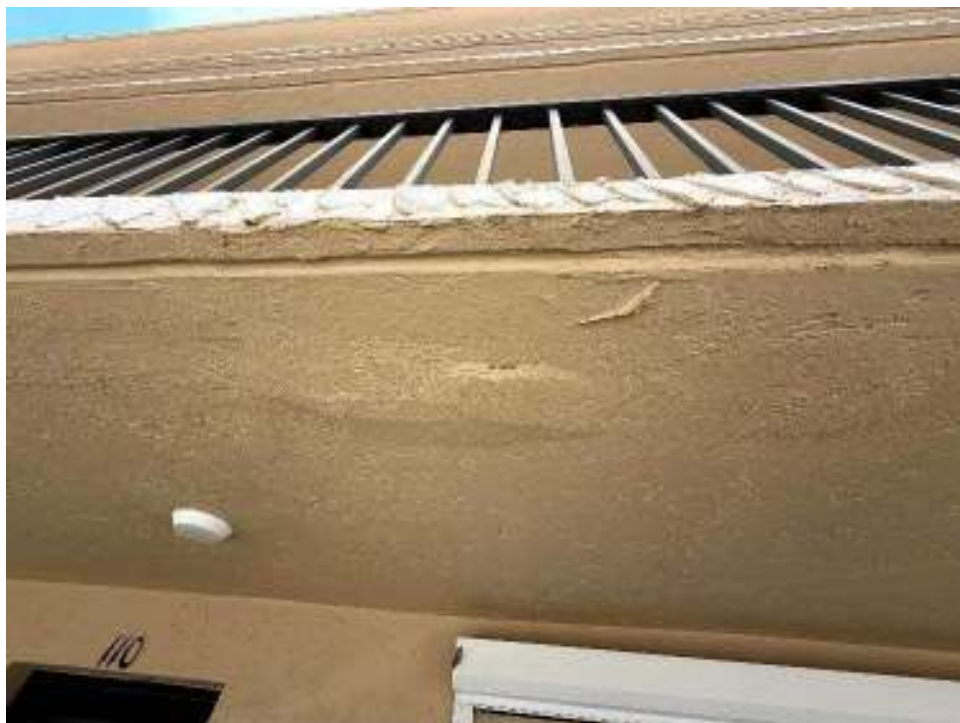
View of edge/ceiling spall along ground floor ceiling walkway

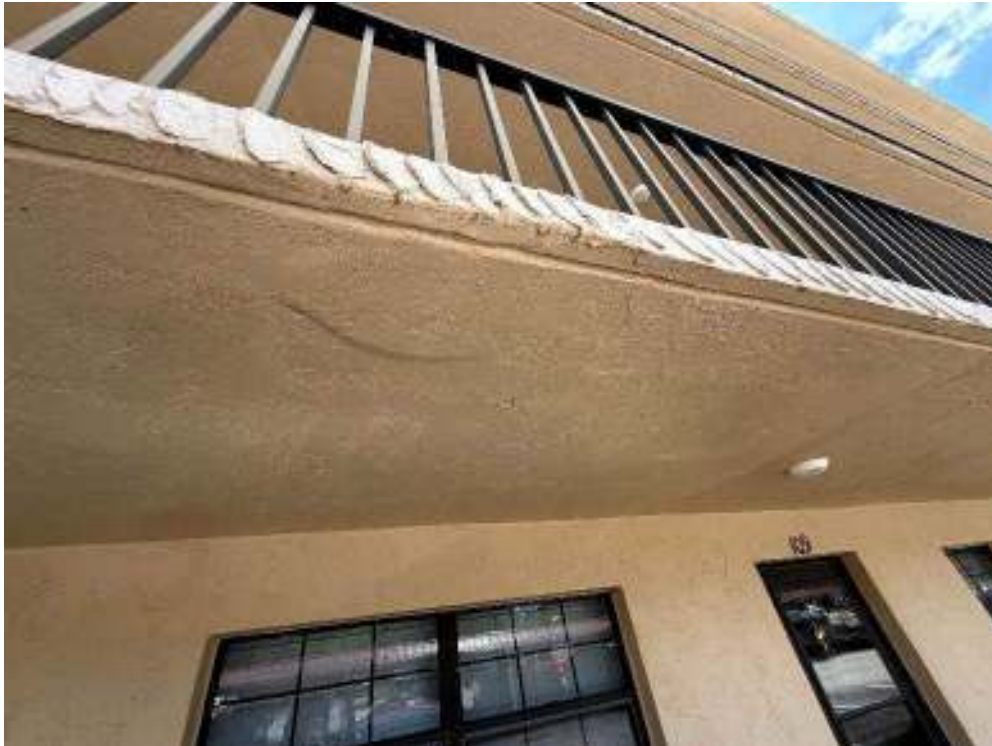
View of edge/ceiling spall along ground floor ceiling walkway

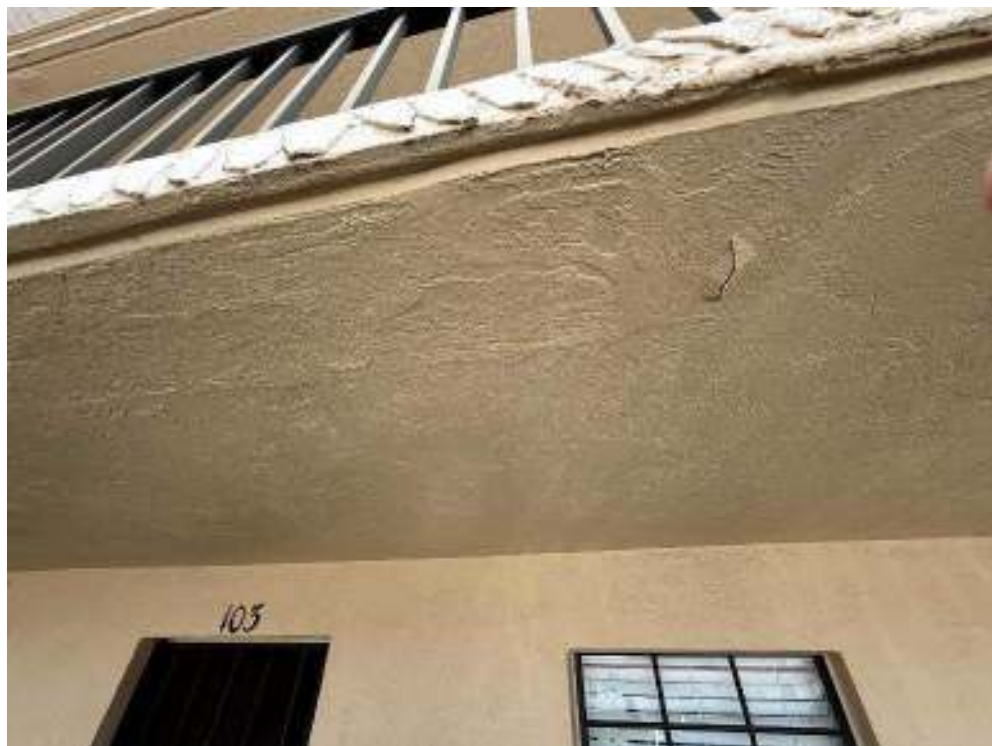
View of ceiling spall along ground floor walkway

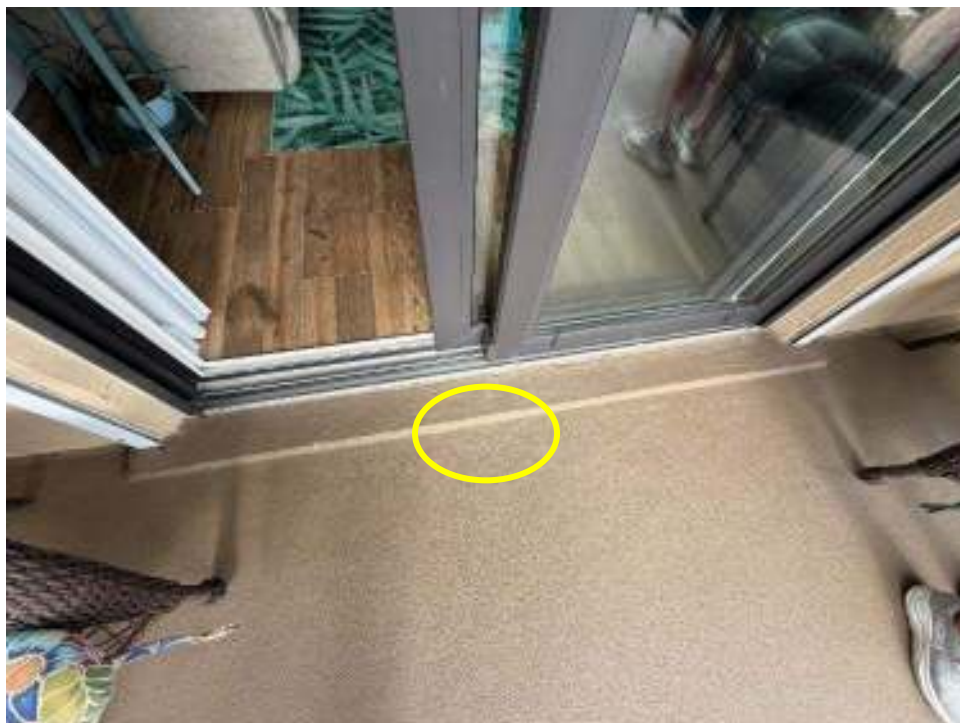
View of spall surface spall in front of door due to reinforcing steel corrosion
