# Indian River Club Condominium

## Structural Condition Survey Report

Prepared By  
**Michael M. Hallenstein, MSCE, P.E.**  
Florida Registered Professional Engineer #98630

**June 8, 2026**

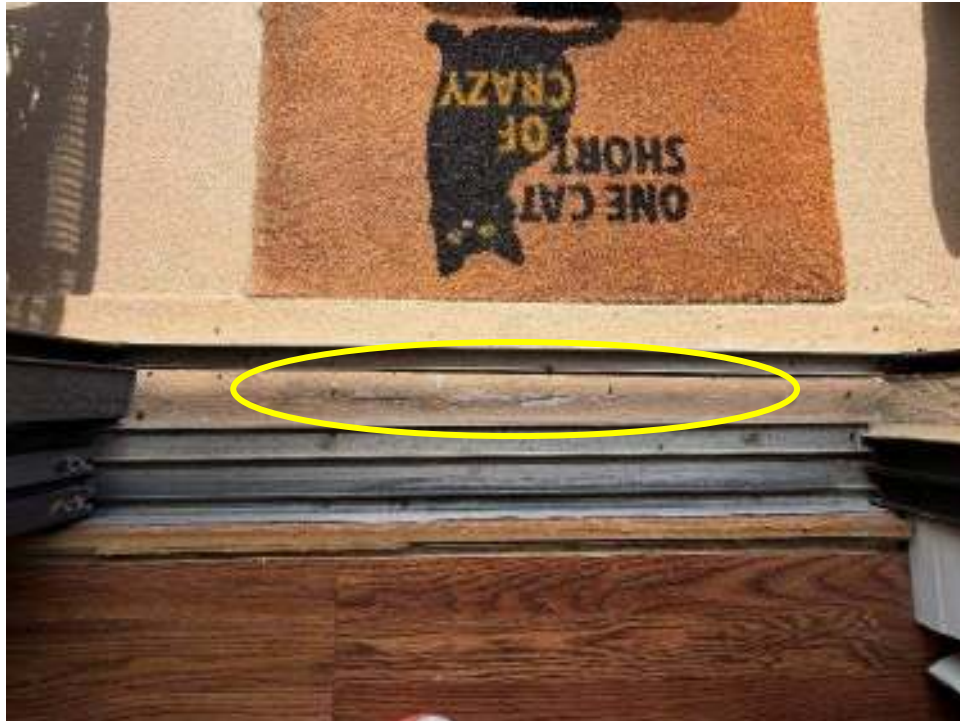
View of cracked door threshold, with likely spall located in slow below

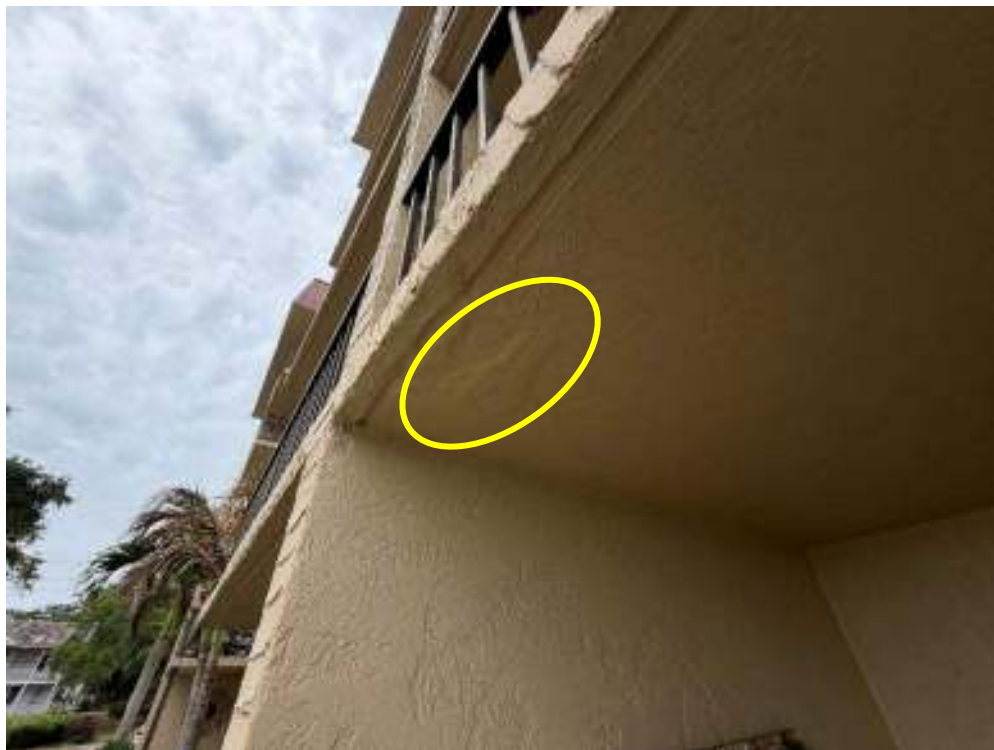
View of ceiling spall due to reinforcing steel corrosion

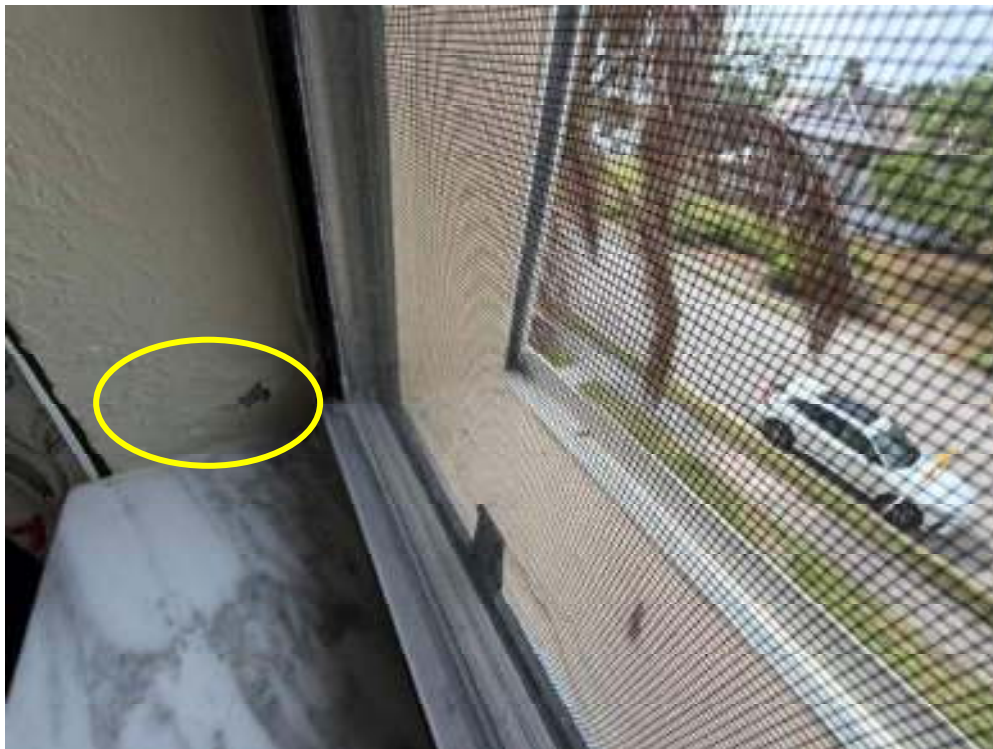
View of interior water damage at windowsill

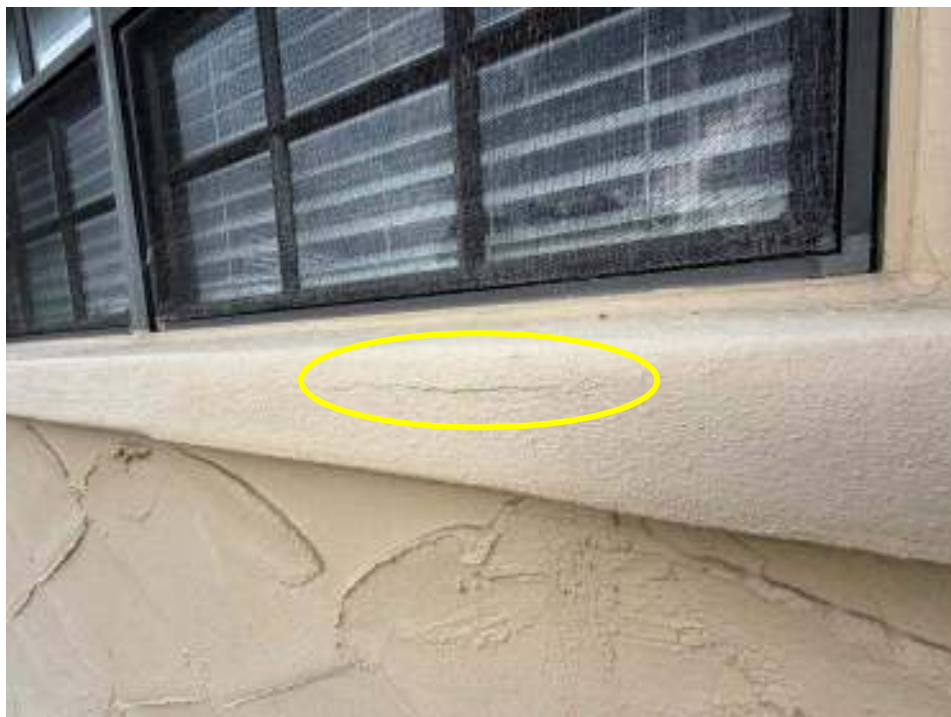
View of spalled windowsill due to reinforcing steel corrosion

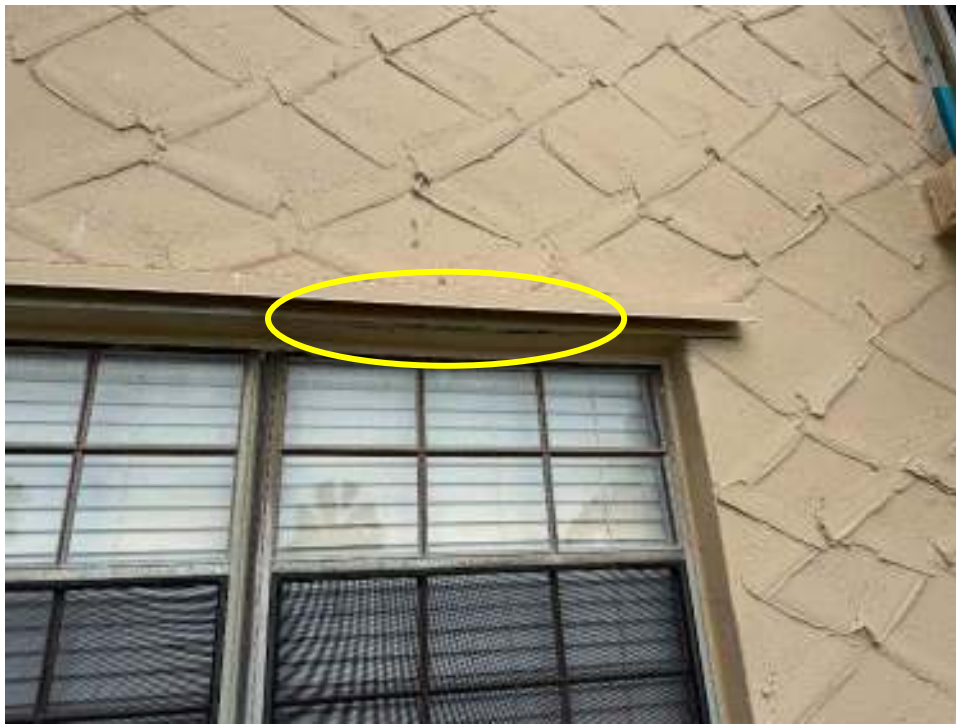
View of header spall above window

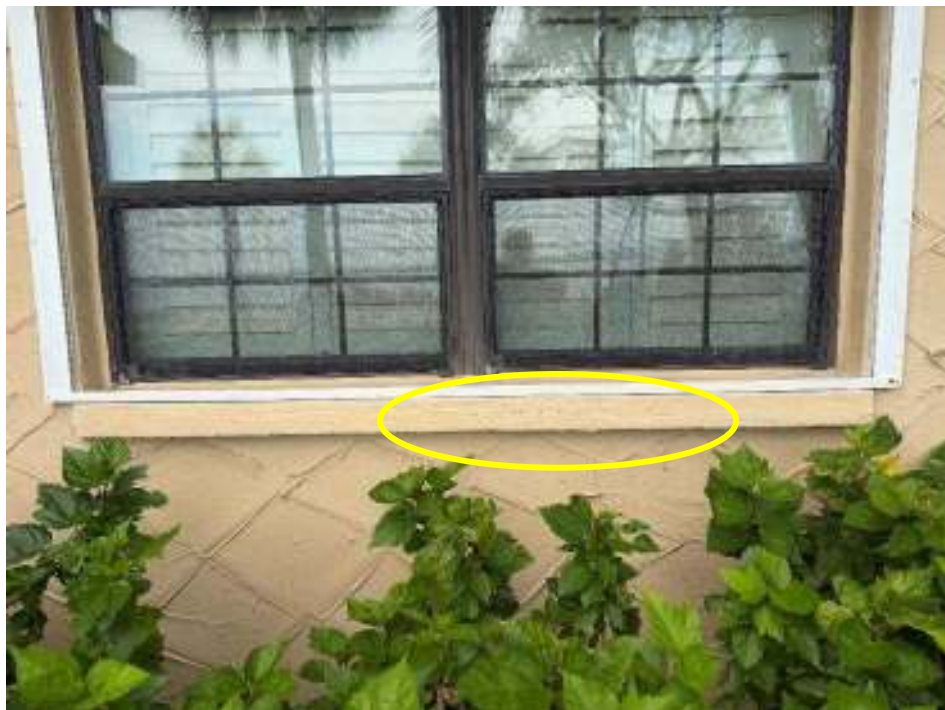
View of spalled windowsill due to reinforcing steel corrosion  
Note deteriorating window frame coatings

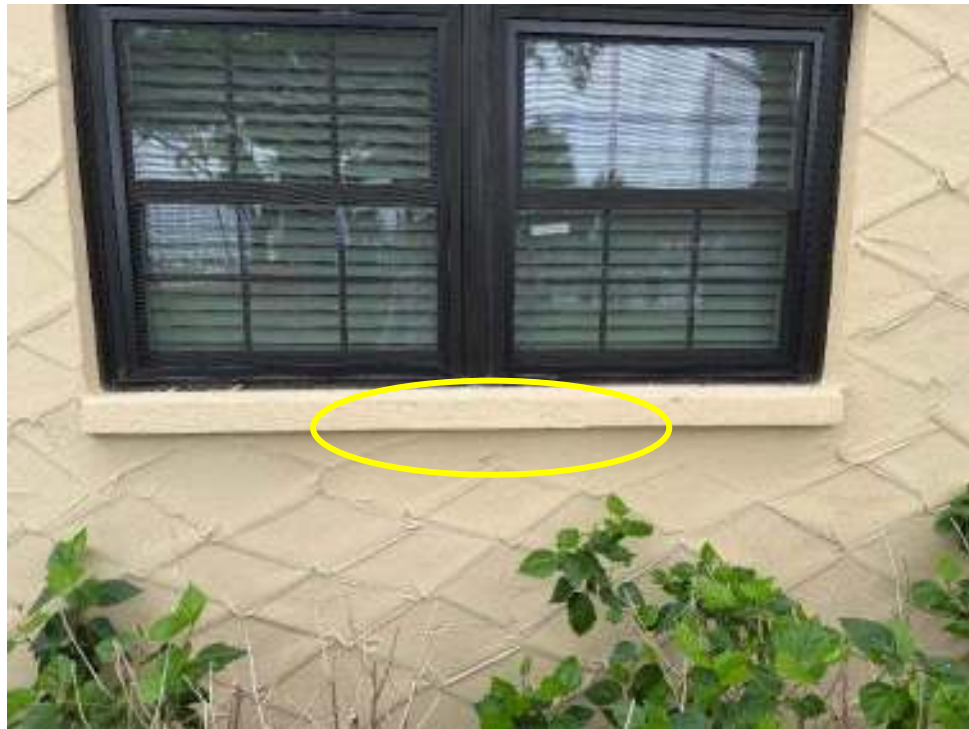
View of patched windowsill spall

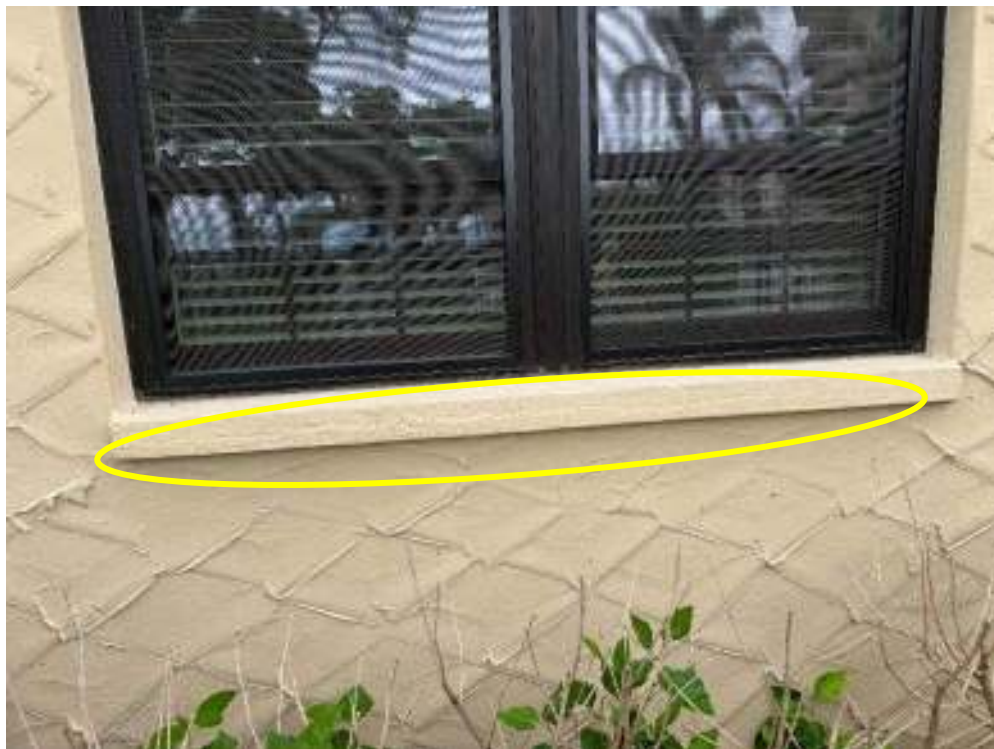
View of windowsill spall

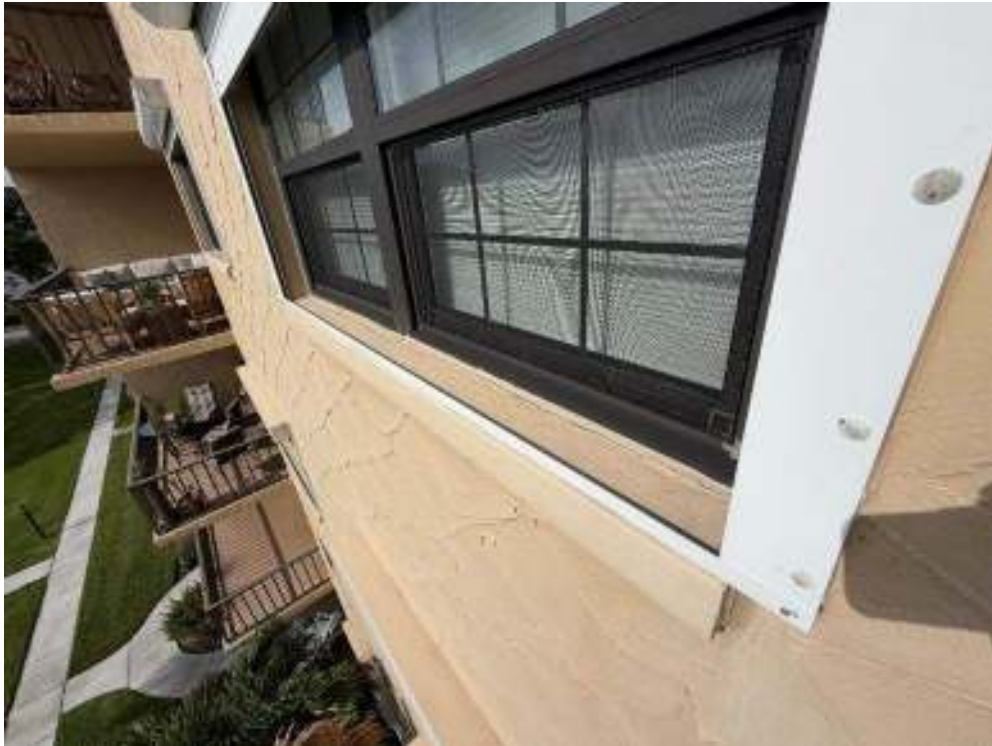
View of failing perimeter sealant

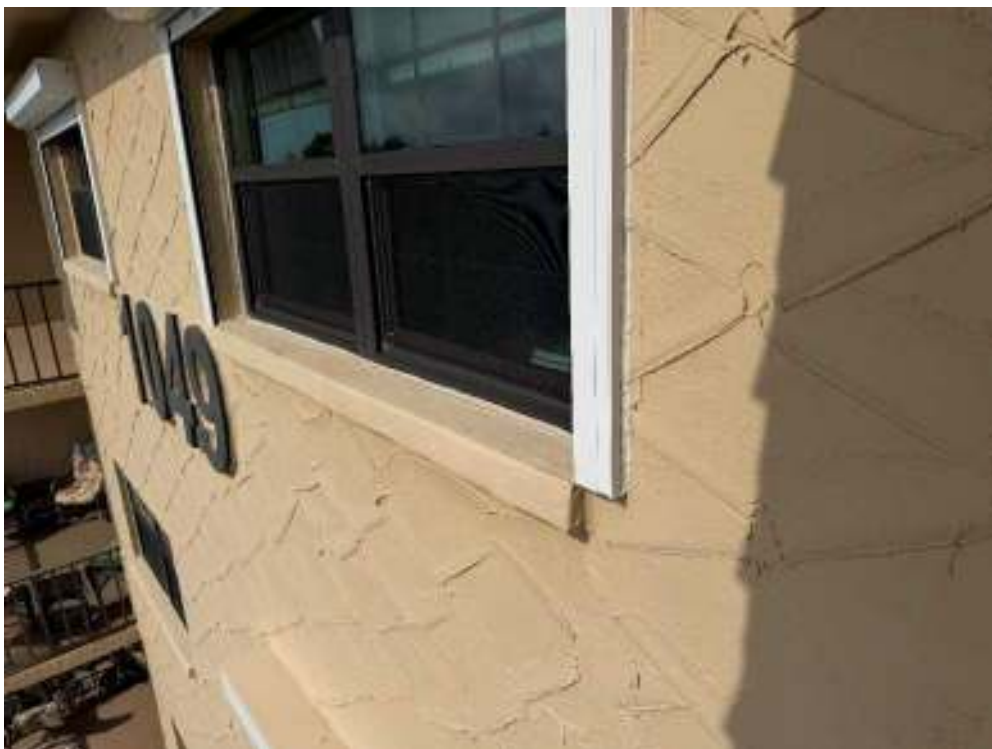
View of failing perimeter sealant

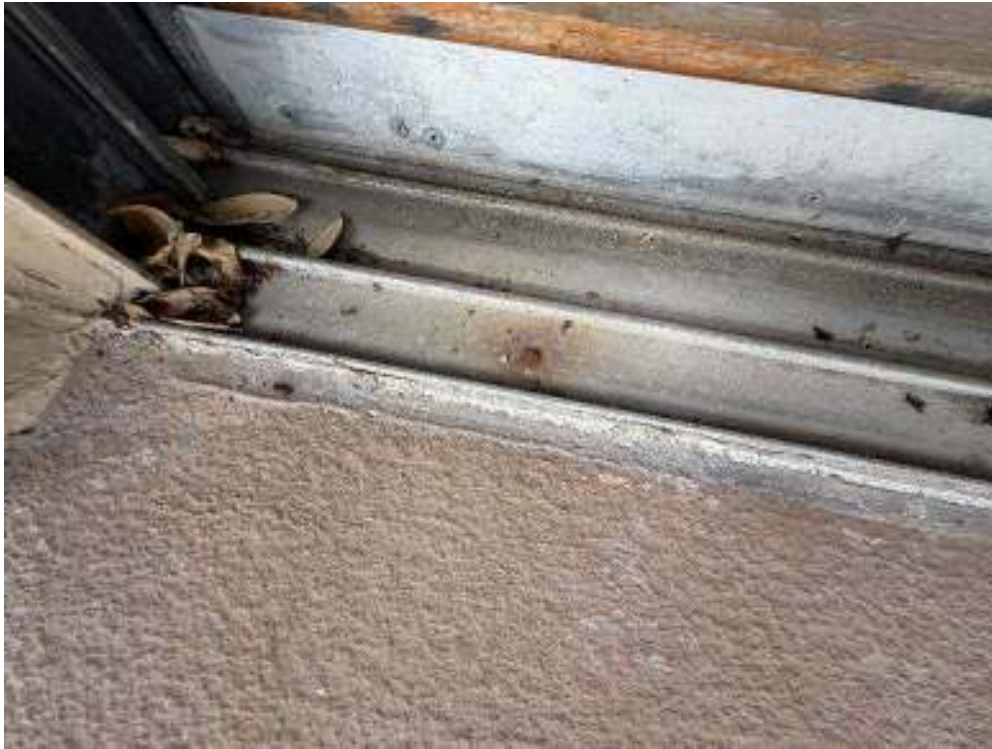
View of corroded sliding glass door fasteners

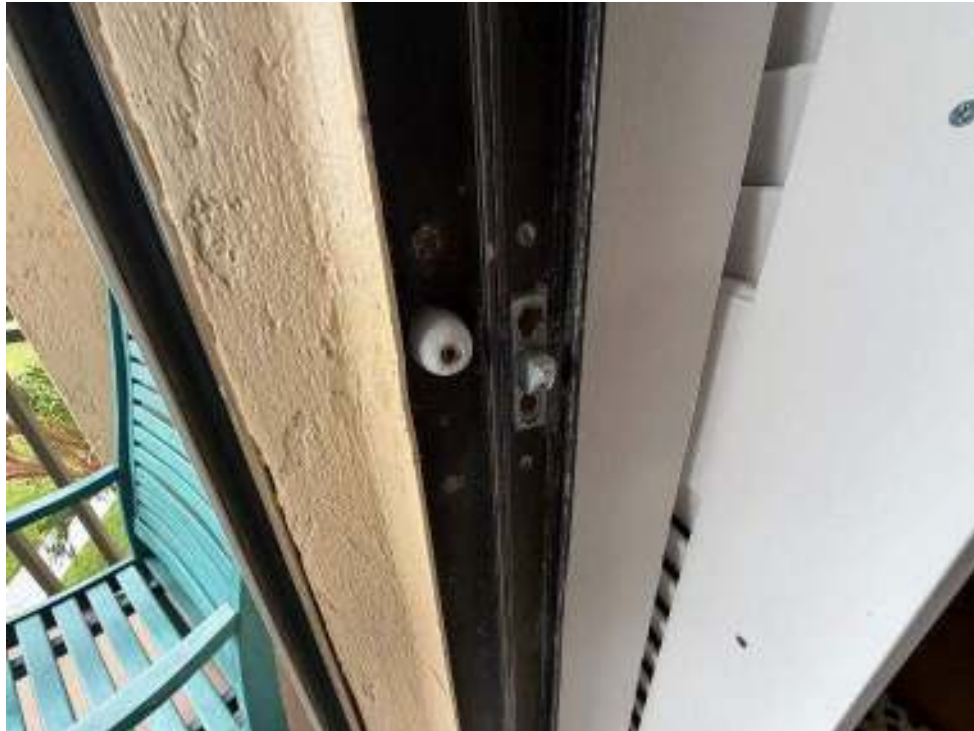
View of corroded sliding glass door fasteners

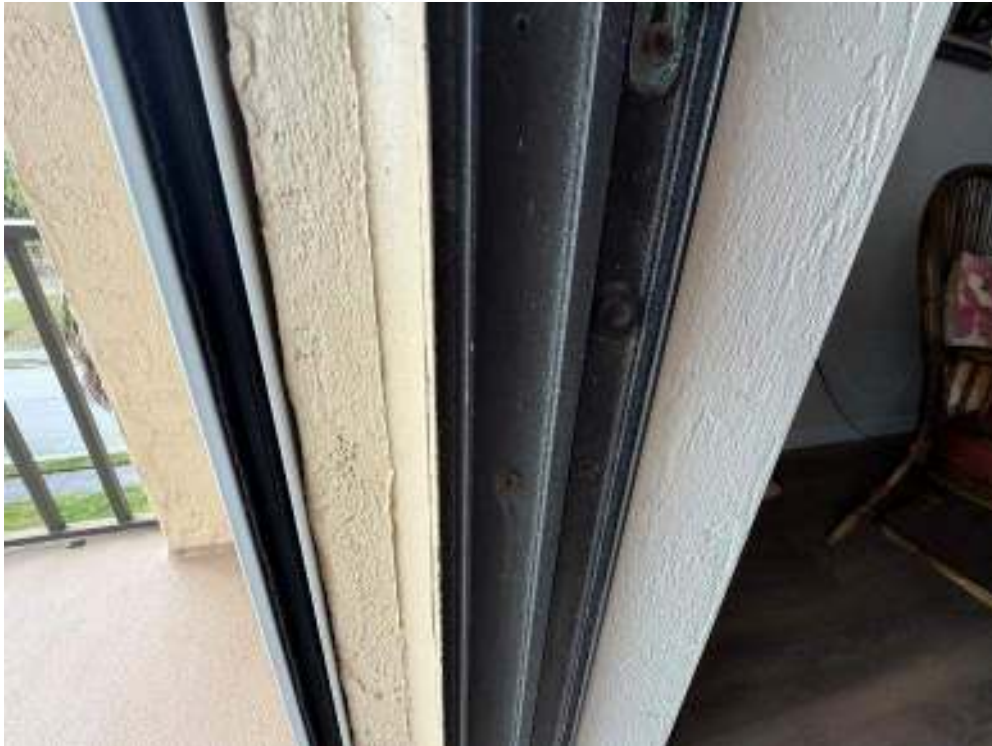
View of corroded and missing sliding glass door fasteners

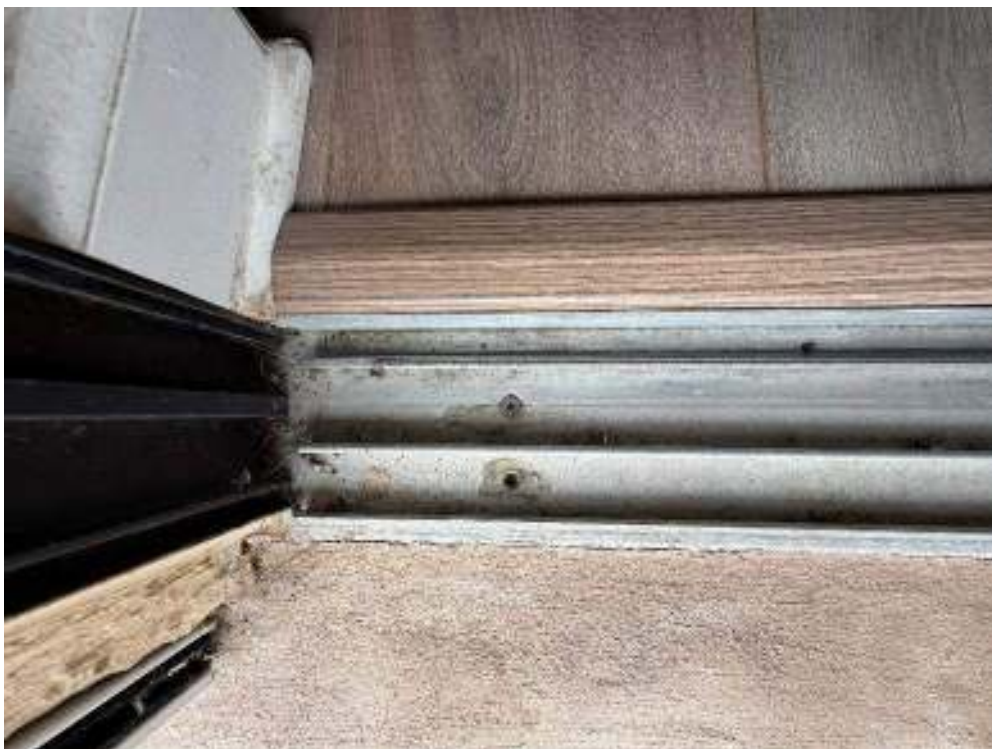
View of corroded and missing sliding glass door fasteners

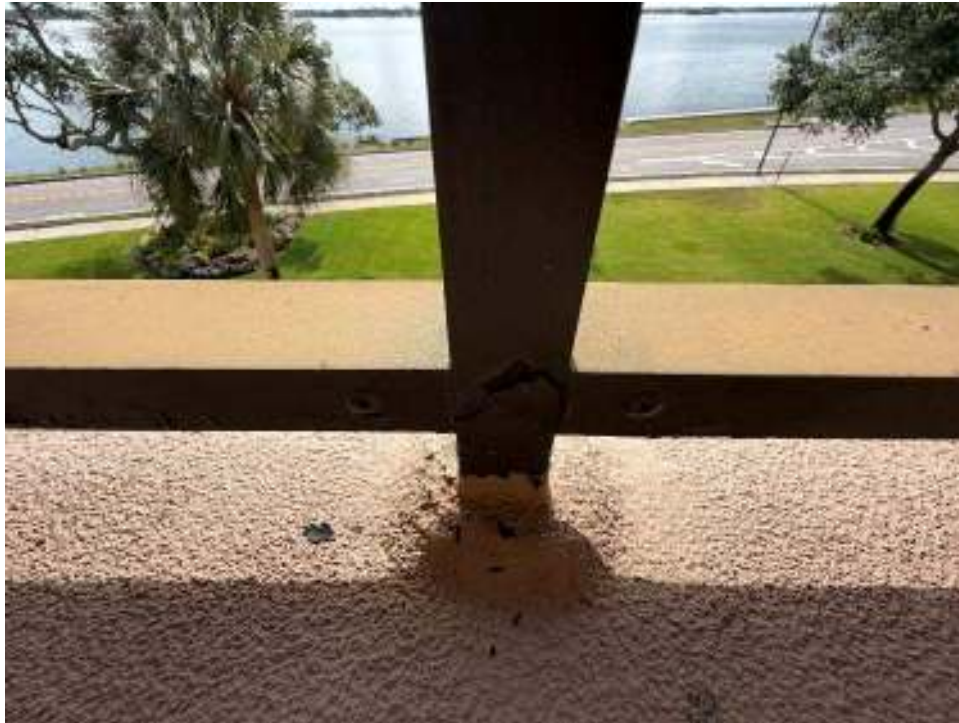
View of corroded cored railing with deteriorating coatings

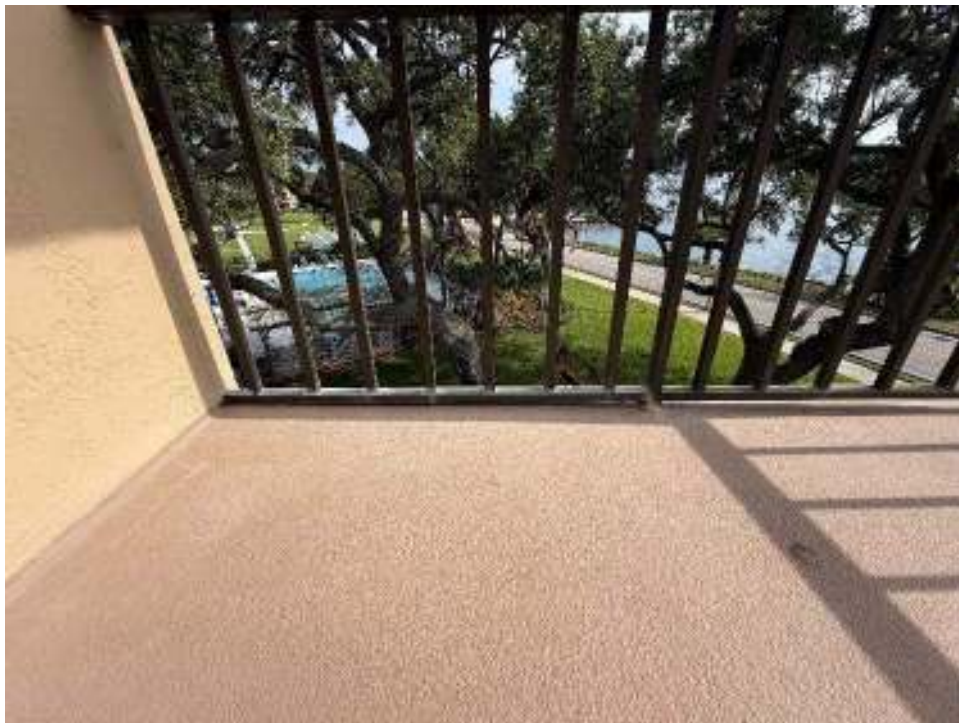
View of typical cored railing with deteriorating coatings

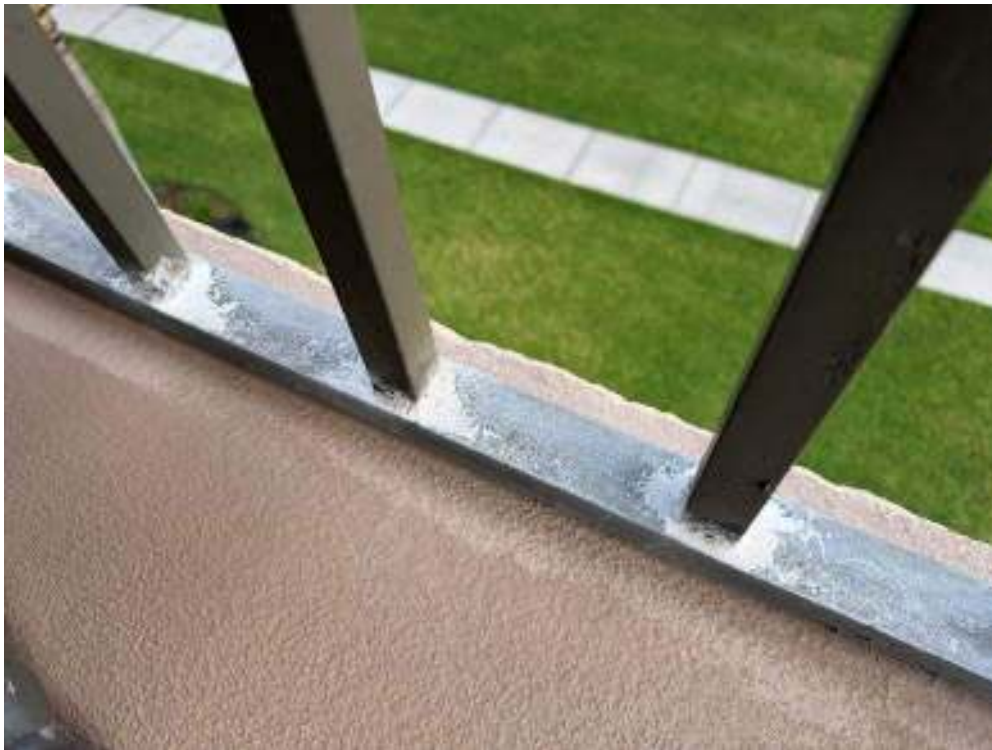
View of deteriorating railing coatings

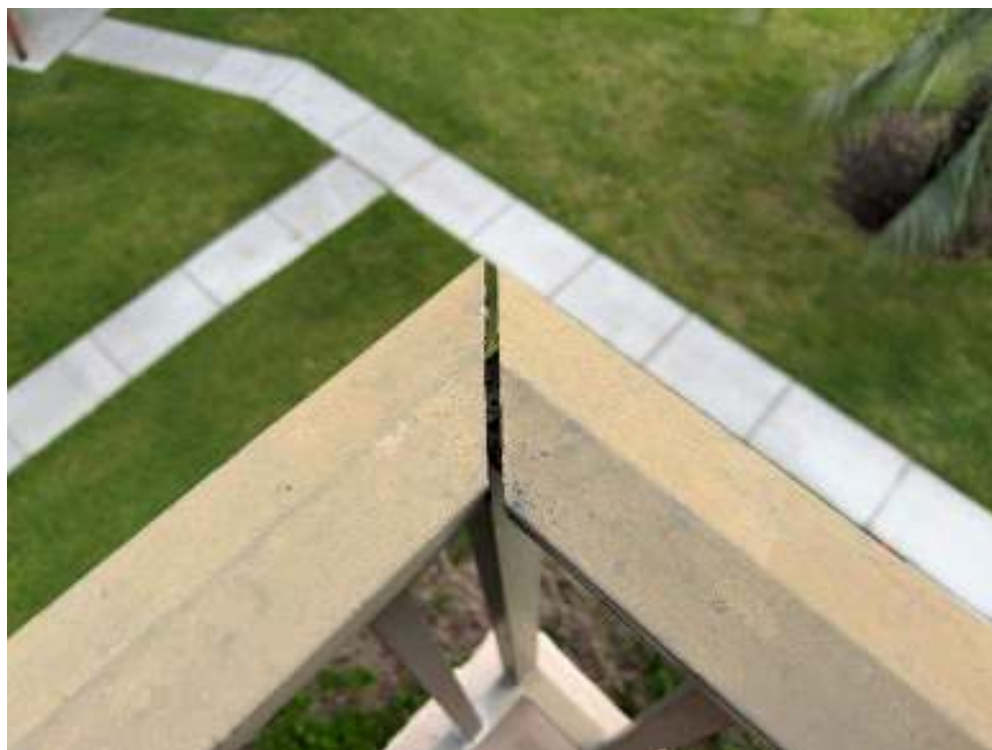
View of pinch hazard on balcony railing

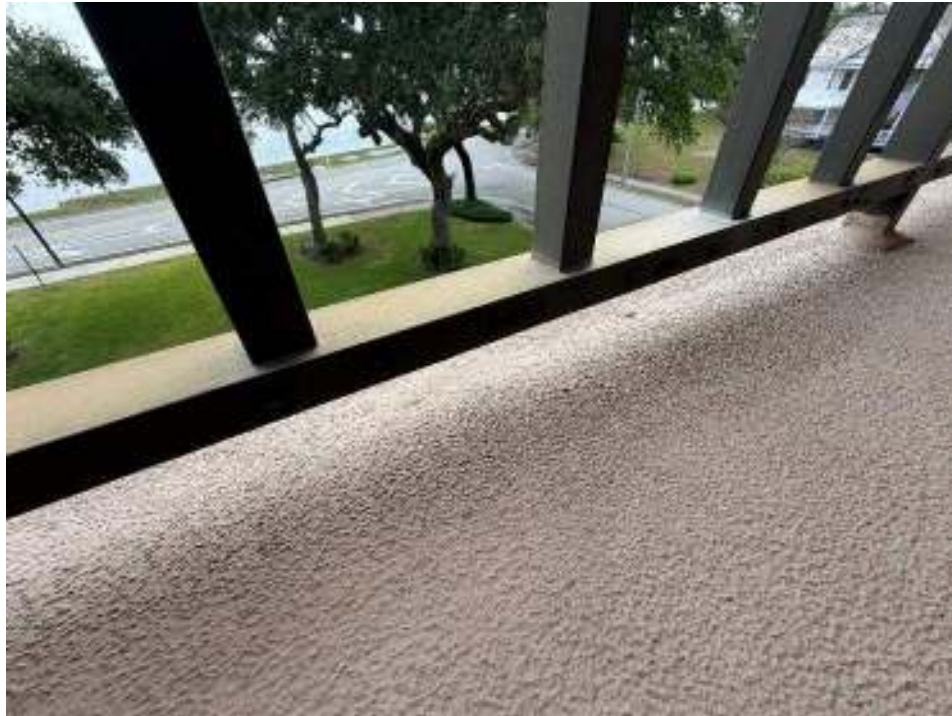
View of deteriorating railing coatings

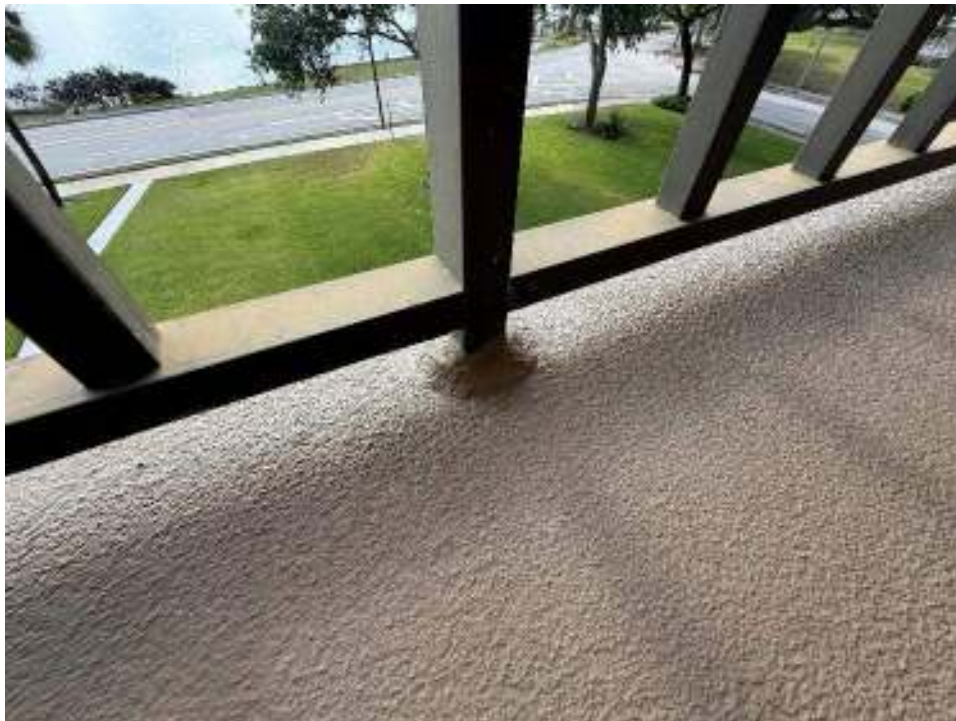
View of deteriorating railing coatings

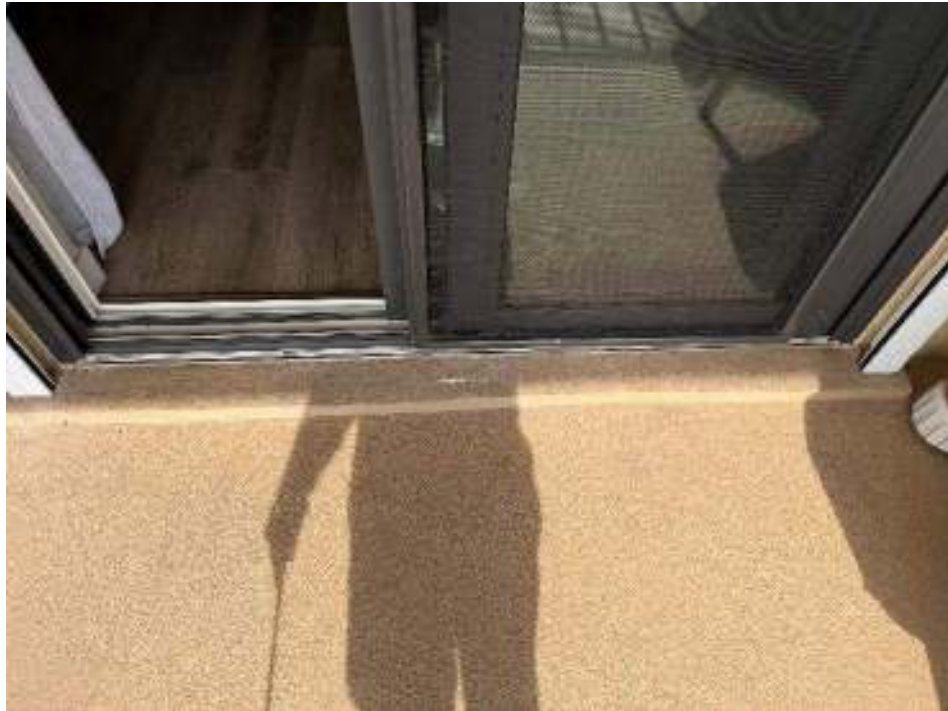
View of damaged floor coatings at sliding glass door threshold

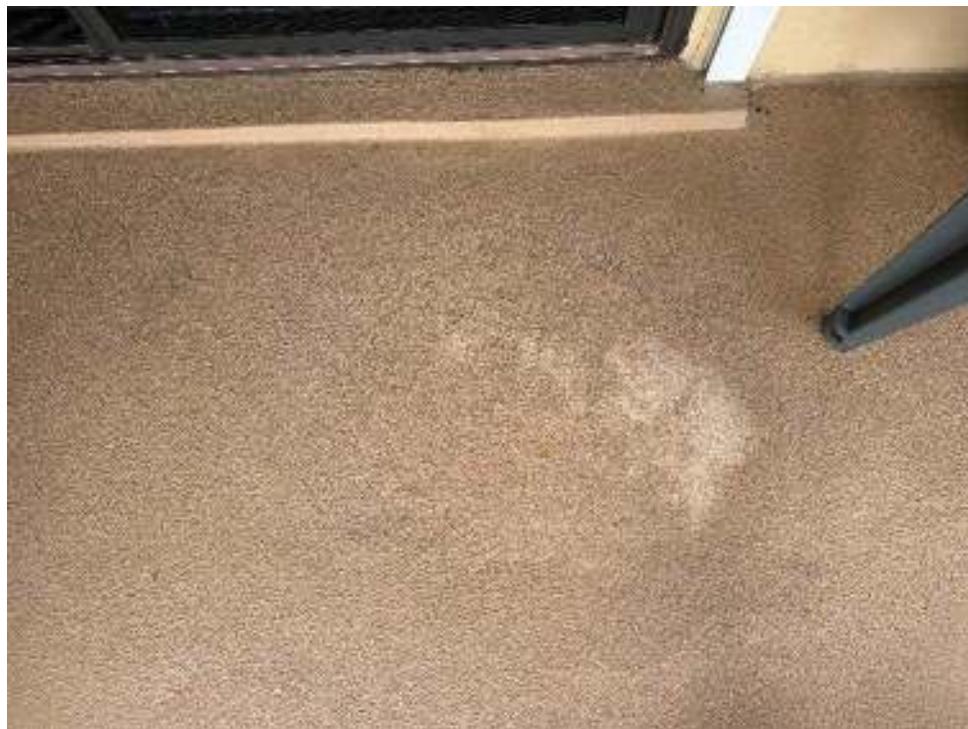
View of deteriorating coatings at previous patch

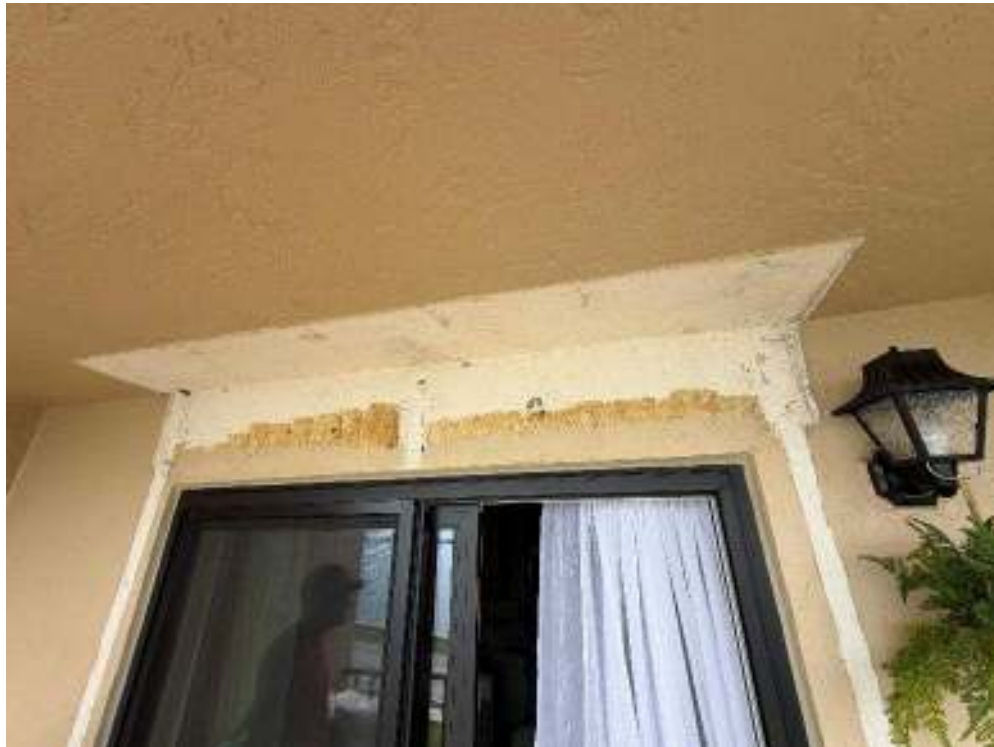
View of missing coatings at shutter removal area

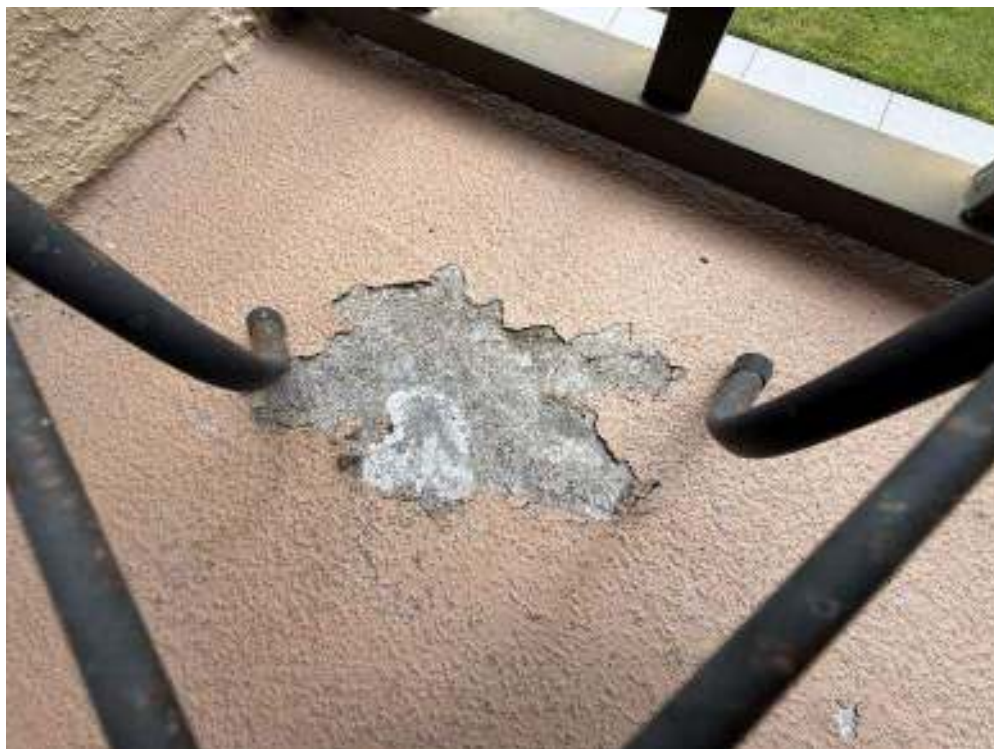
View of deteriorating coatings

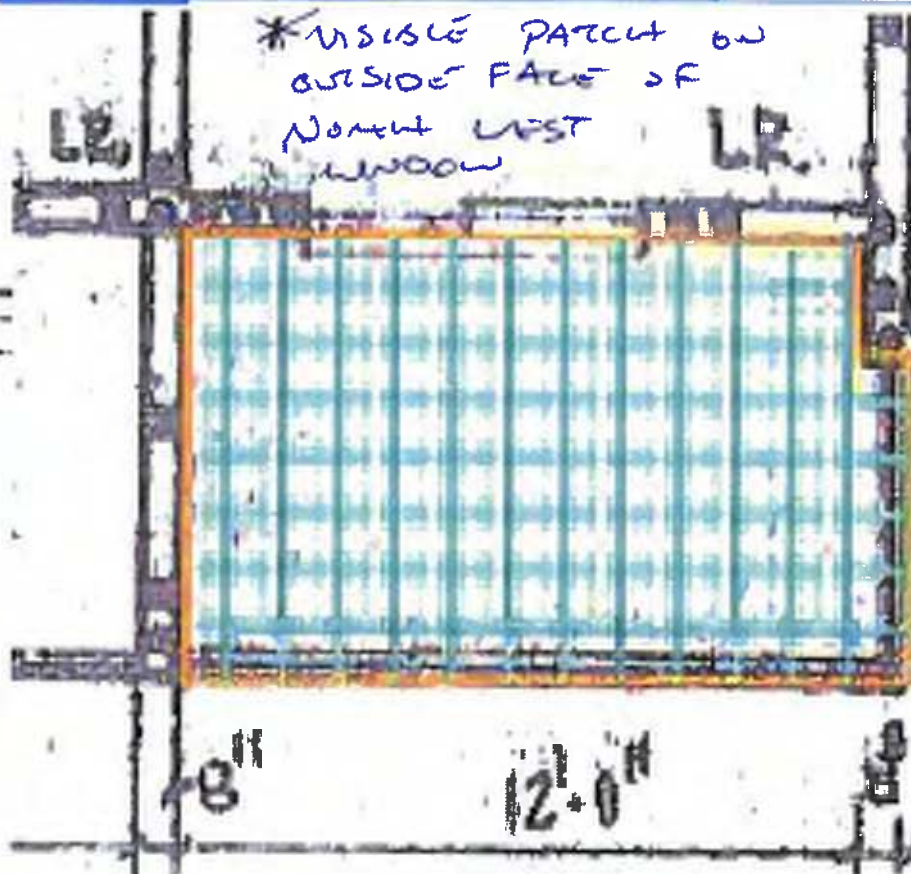
- POINTING  
LE WINDOW  
HEAD  
SPACE  
ABOVE  
WEST WINDOW,  
ABOVE 301  
LEAKAGE,  
PREVIOUSLY  
SEALED

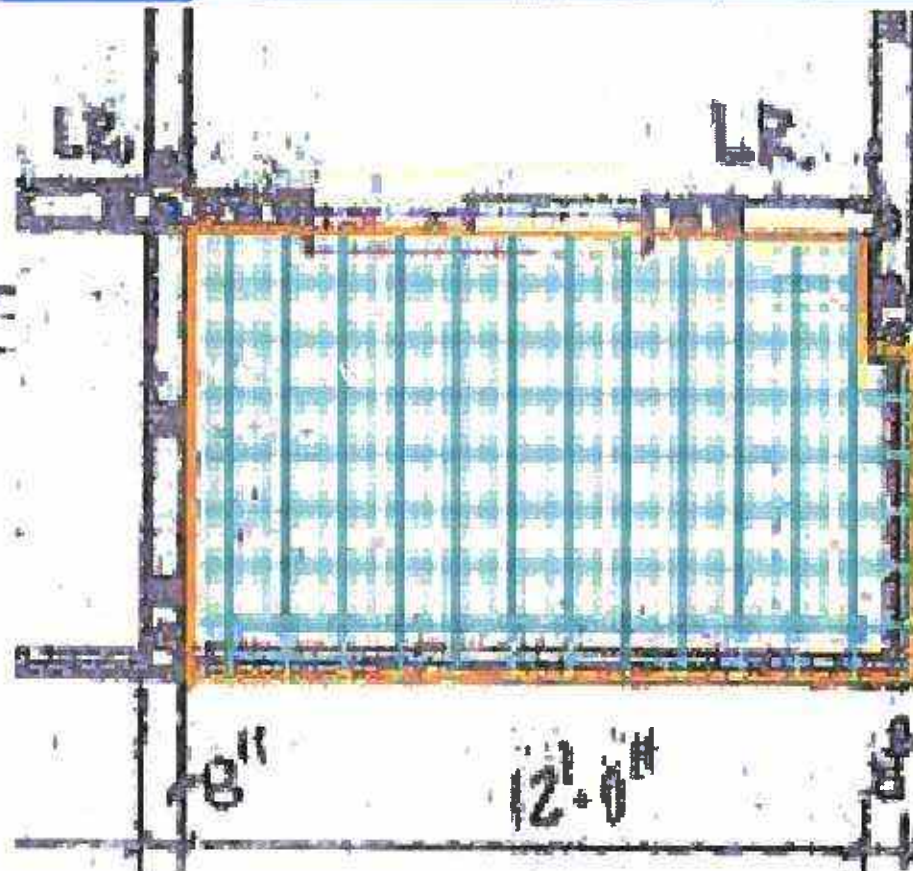
- WATER  
INTRUSION IN  
WEST WINDOW  
FROM ABOVE (45)

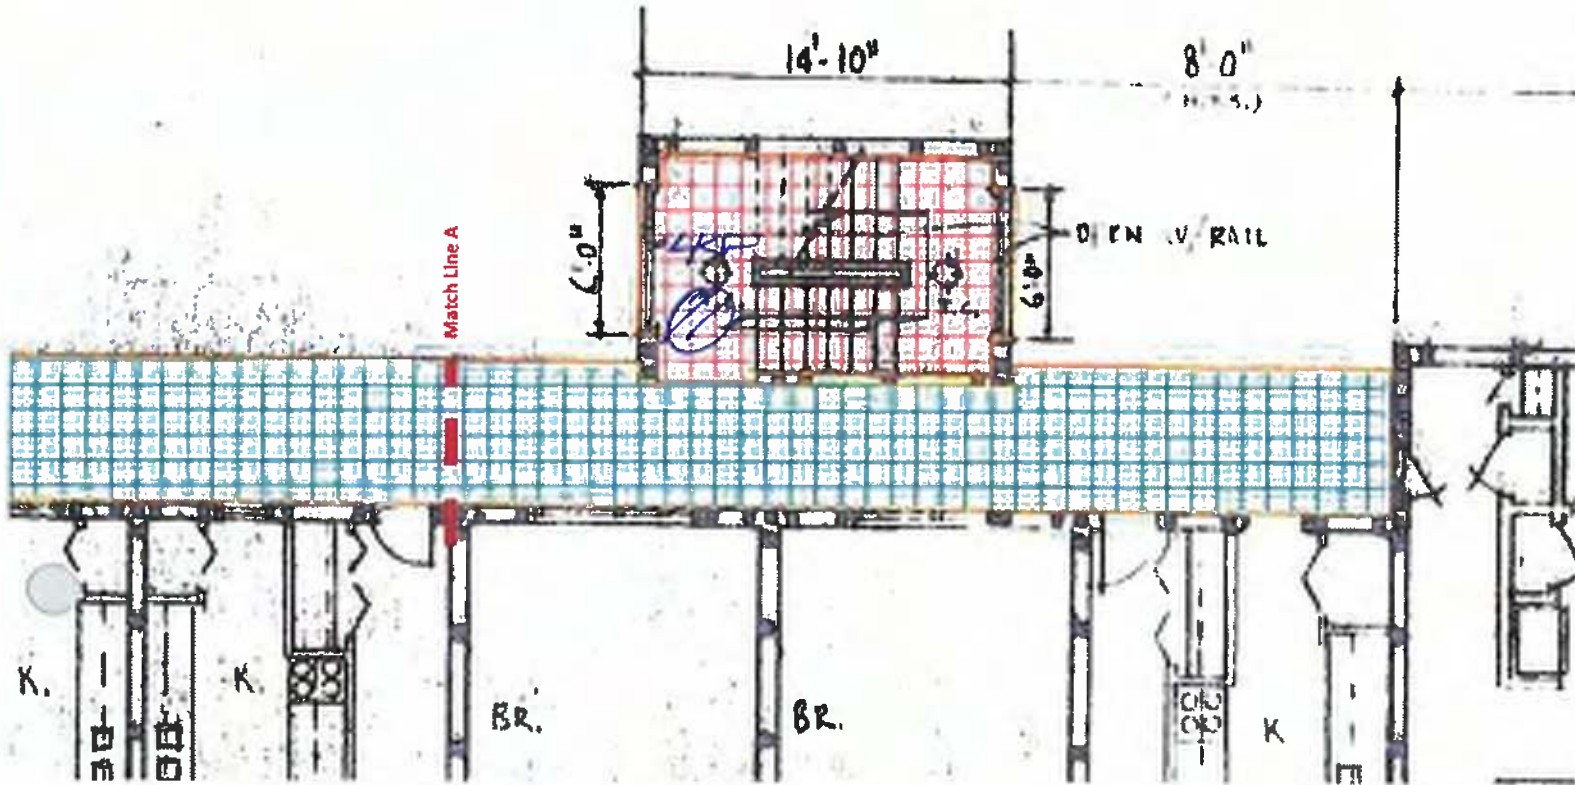
Level # 41

- CRACKS CONSISTENT  
WITH COATINGS
