# Indian River Club Condominium

## Structural Condition Survey Report

Prepared By  
**Michael M. Hallenstein, MSCE, P.E.**  
Florida Registered Professional Engineer #98630

**June 8, 2026**

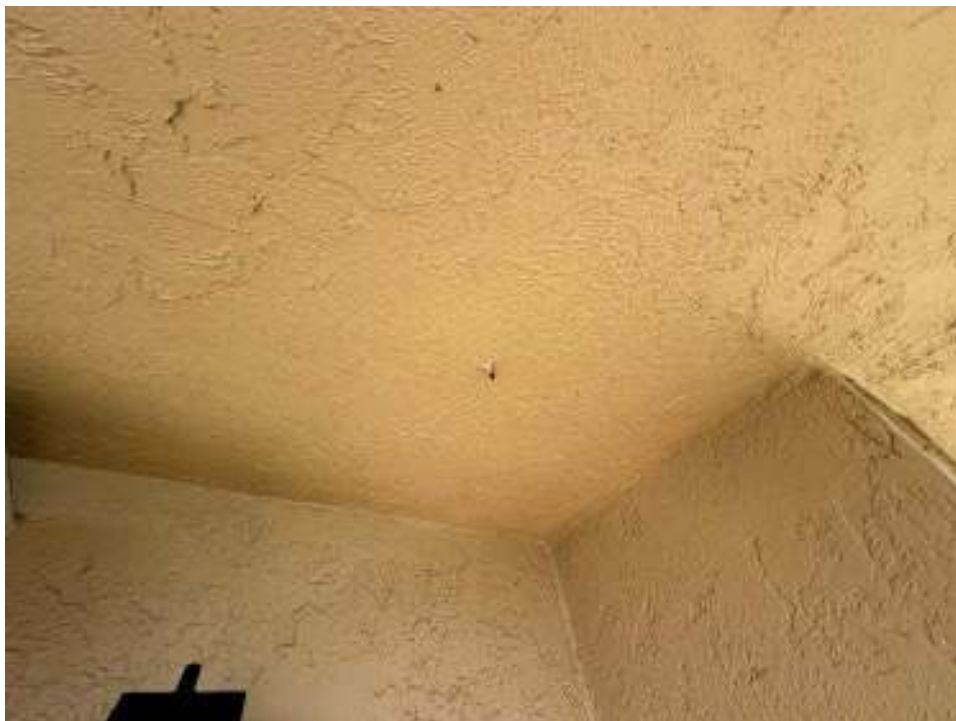
View of abandoned fastener in balcony ceiling
