# Indian River Club Condominium

## Structural Condition Survey Report

Prepared By  
**Michael M. Hallenstein, MSCE, P.E.**  
Florida Registered Professional Engineer #98630

**June 8, 2026**

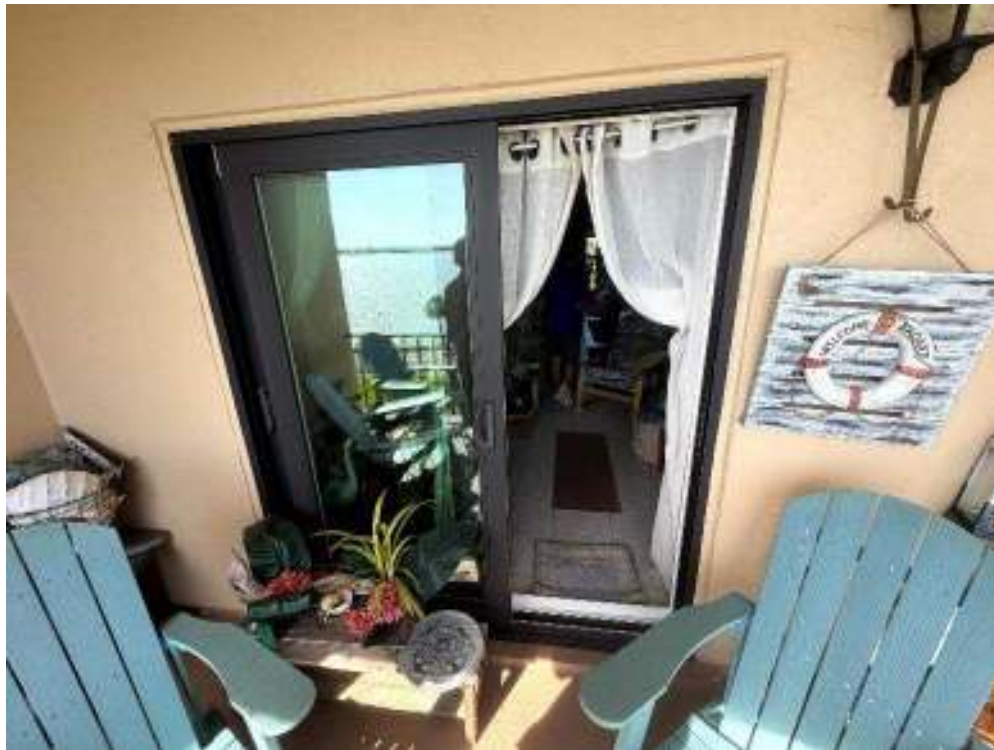
View of newer sliding glass door

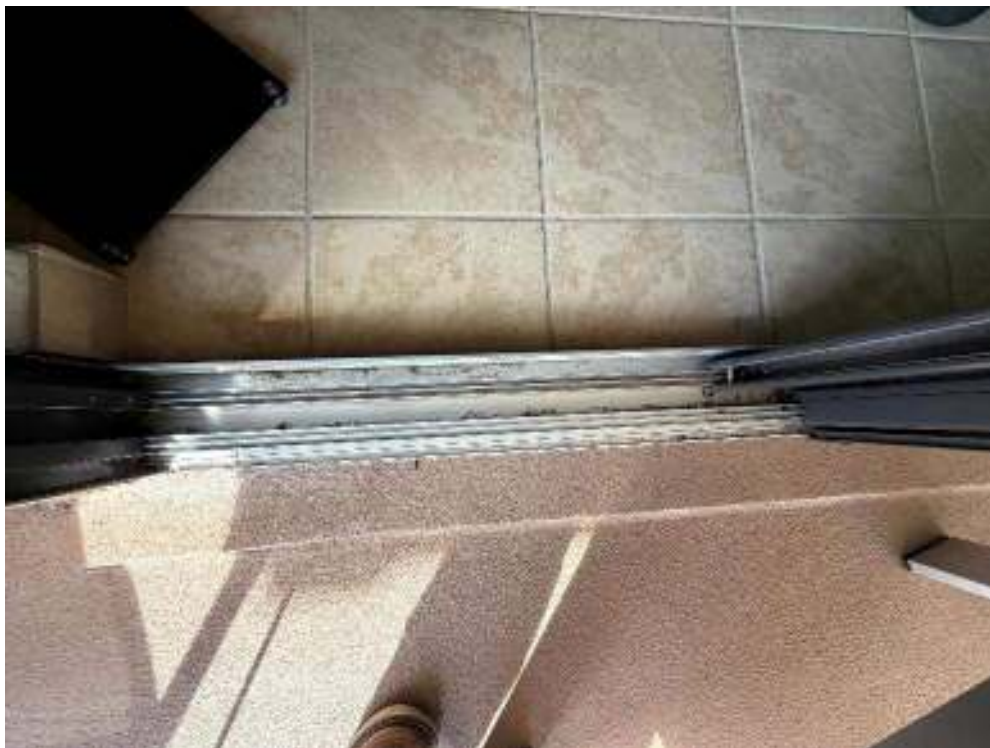
View of newer sliding glass door
